SWEETWATER COVE LAKE LYNGBYA NUTRIENT SOURCE EVALUATION

Final Report – December 2015

Seminole County, Florida

**Environmental Research & Design, Inc.
Harvey H. Harper, Ph.D., P.E. – Project Director
3419 Trentwood Blvd., Suite 102
Belle Isle (Orlando), FL 32812-4864
407-855-9465**

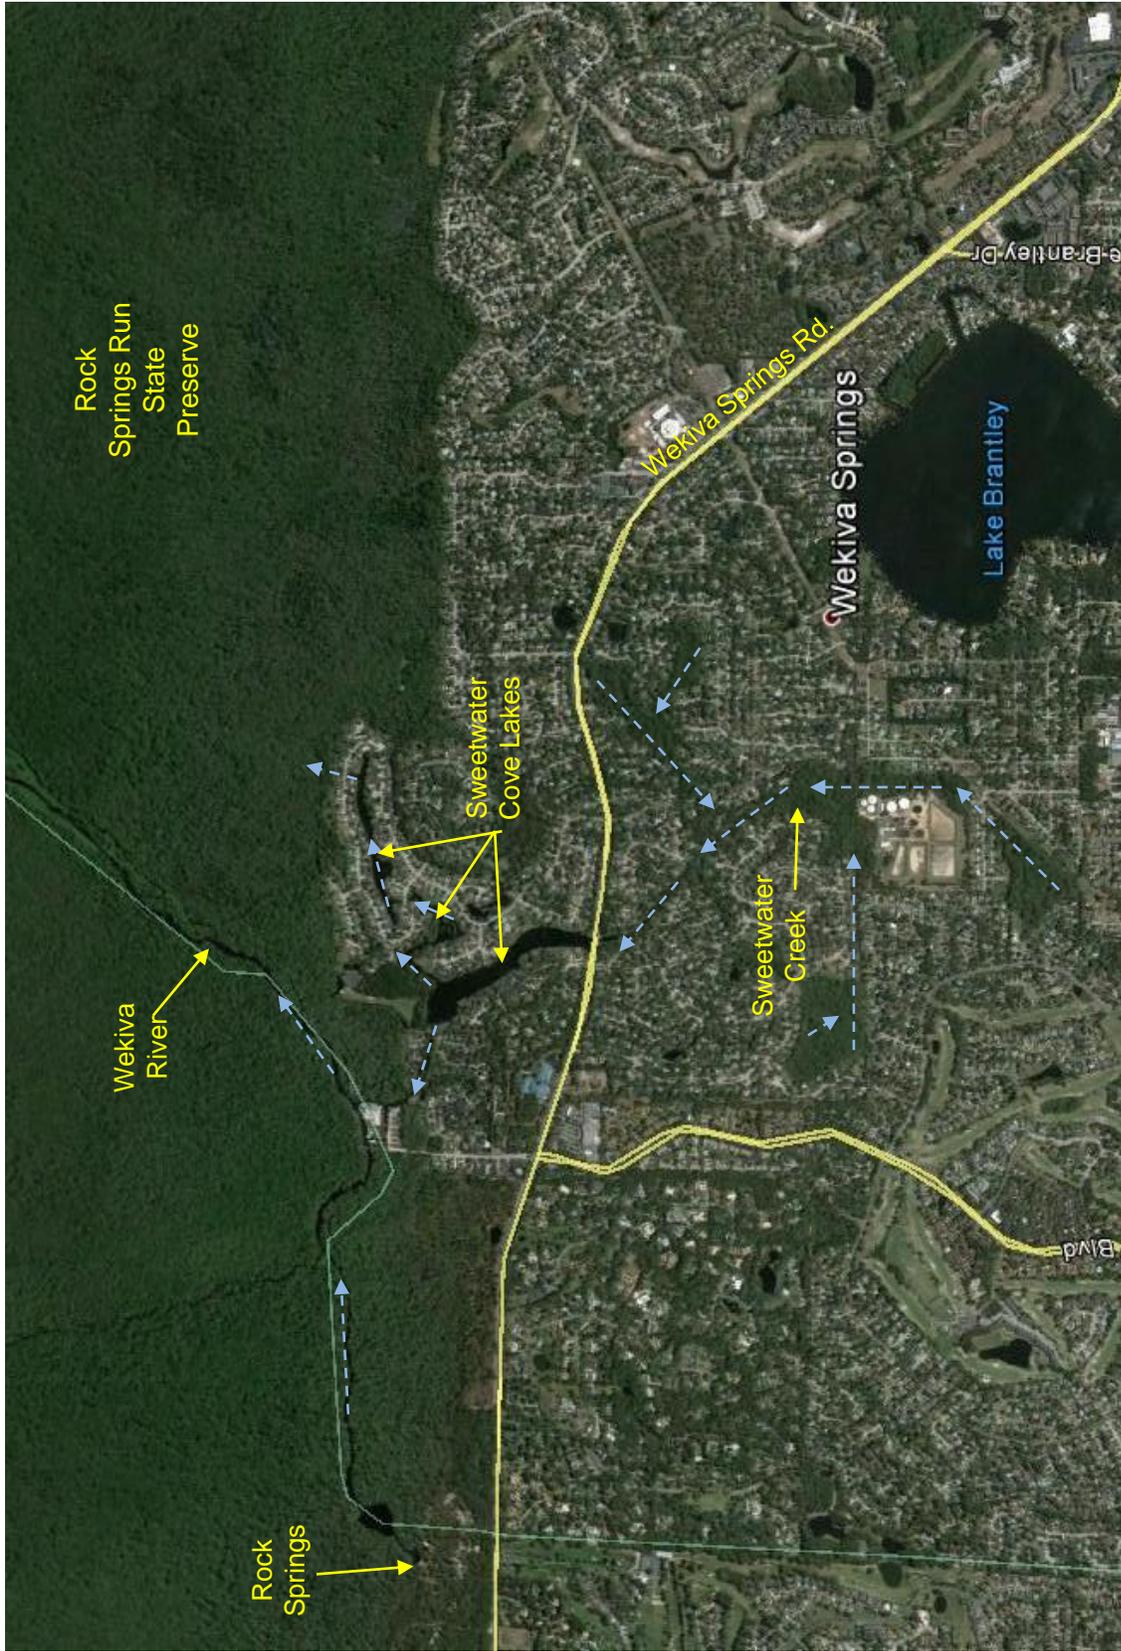
Figure 1-2. Overview of Sweetwater Cove and Hydrologic Features.

An overview of Sweetwater Cove and associated hydrologic features is given on Figure 1-2. Sweetwater Cove Lake consists of three interconnected waterbodies which receive inflows from Sweetwater Creek. Sweetwater Creek provides drainage for multiple residential communities and contains several connecting tributaries. A wastewater treatment plant, operated by Sanlando Utilities, discharged treated secondary effluent to Sweetwater Creek until 2013 when an alternate disposal technique was adopted. Under current conditions, the plant is permitted for wet weather discharges into Sweetwater Creek when the sewage flows received by the facility exceed the capacity of the on-site infiltration basins.

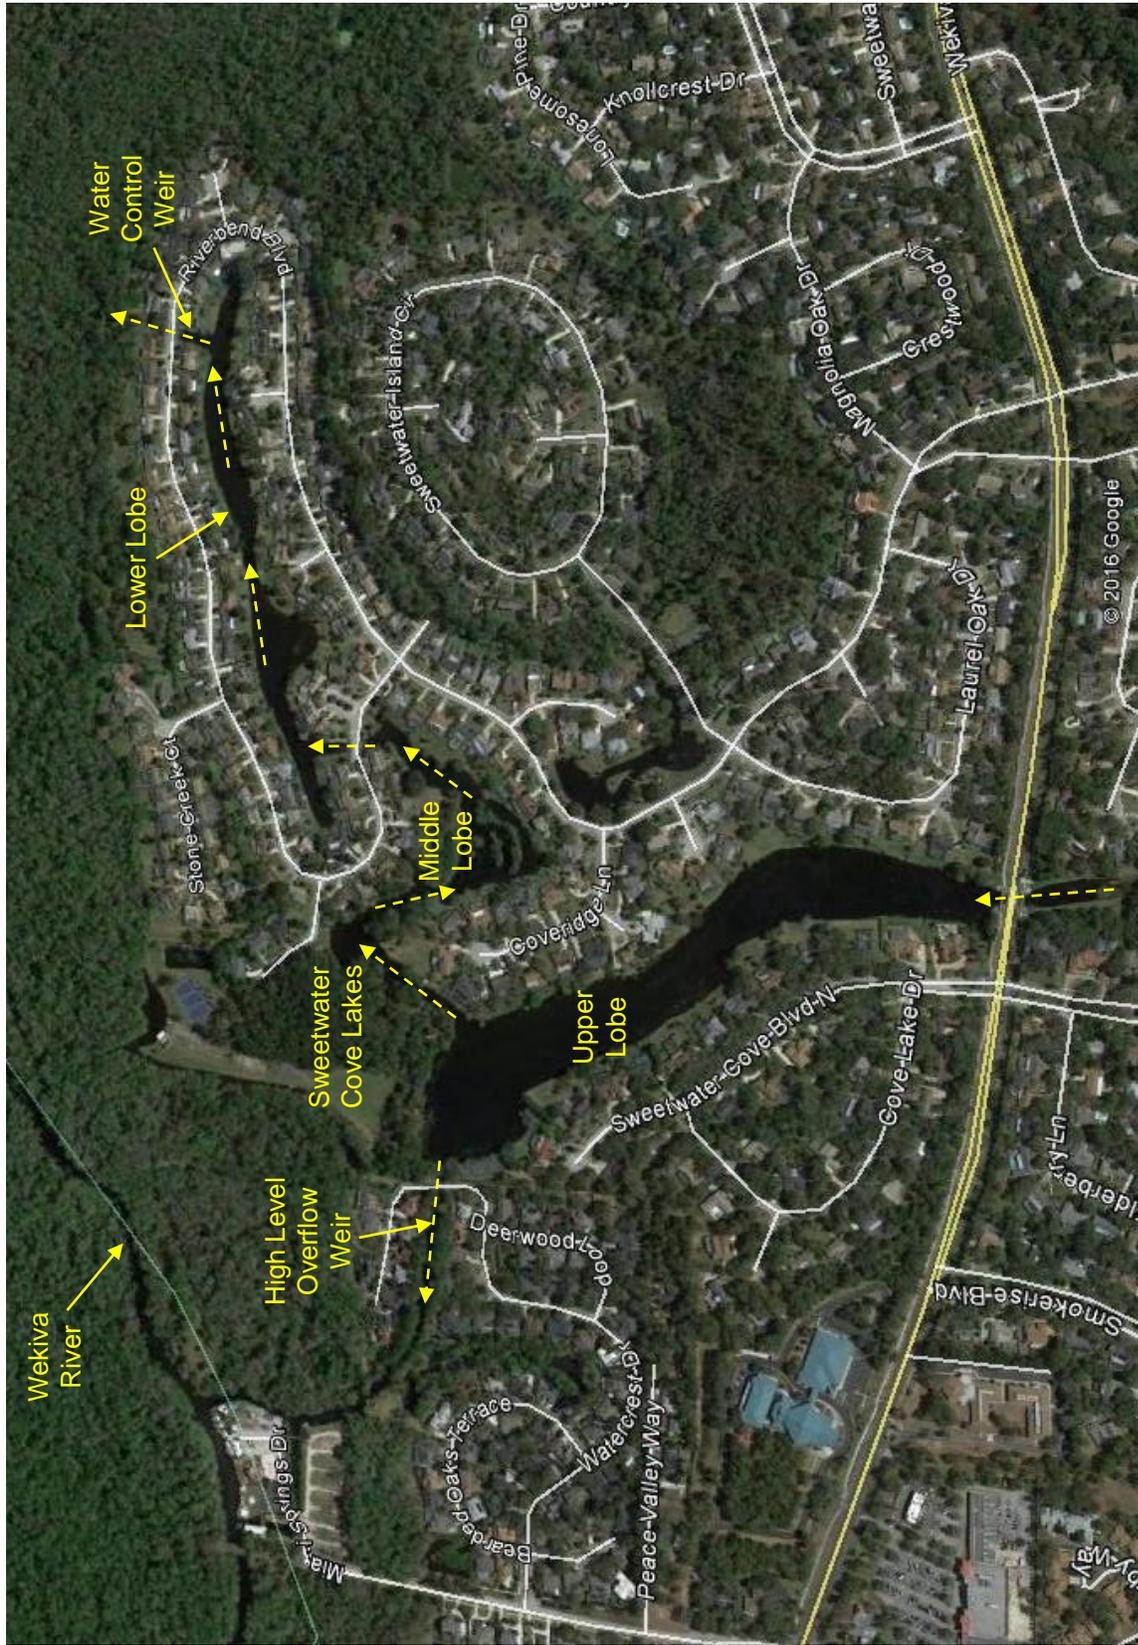
Figure 1-3. Overview of Drainage Flow Patterns for Sweetwater Cove Lake.

An overview of drainage flow patterns for Sweetwater Cove Lake is given on Figure 1-3. Sweetwater Cove Lake is divided into three separate waterbodies identified as the upper, middle, and lower lobes of Sweetwater Cove Lake. The general flow pattern within the lakes originates with the inflow of Sweetwater Creek into the southern portion of the upper lobe. Under normal flow conditions, water discharges from the upper lobe to the middle lobe, finally reaching the lower lobe of Sweetwater Cove Lake. The lower lobe has a water surface area of approximately 4.55 acres and shallow water depths ranging from approximately 2-4 ft. Water level elevations within the lower lobe, as well as in other portions of Sweetwater Cove Lake, are controlled at

elevation 20.9 ft by a semicircular concrete weir structure, approximately 57.2 ft in length, located in the northeast portion of the lower lobe. Discharges through the outfall structure flow northward into the Rock Springs Run State Preserve. Under high water level conditions, water can also discharge from the upper lobe over a high level overflow weir which connects directly with the Wekiva River. The work efforts outlined in this document were conducted exclusively within the lower lobe of Sweetwater Cove Lake.

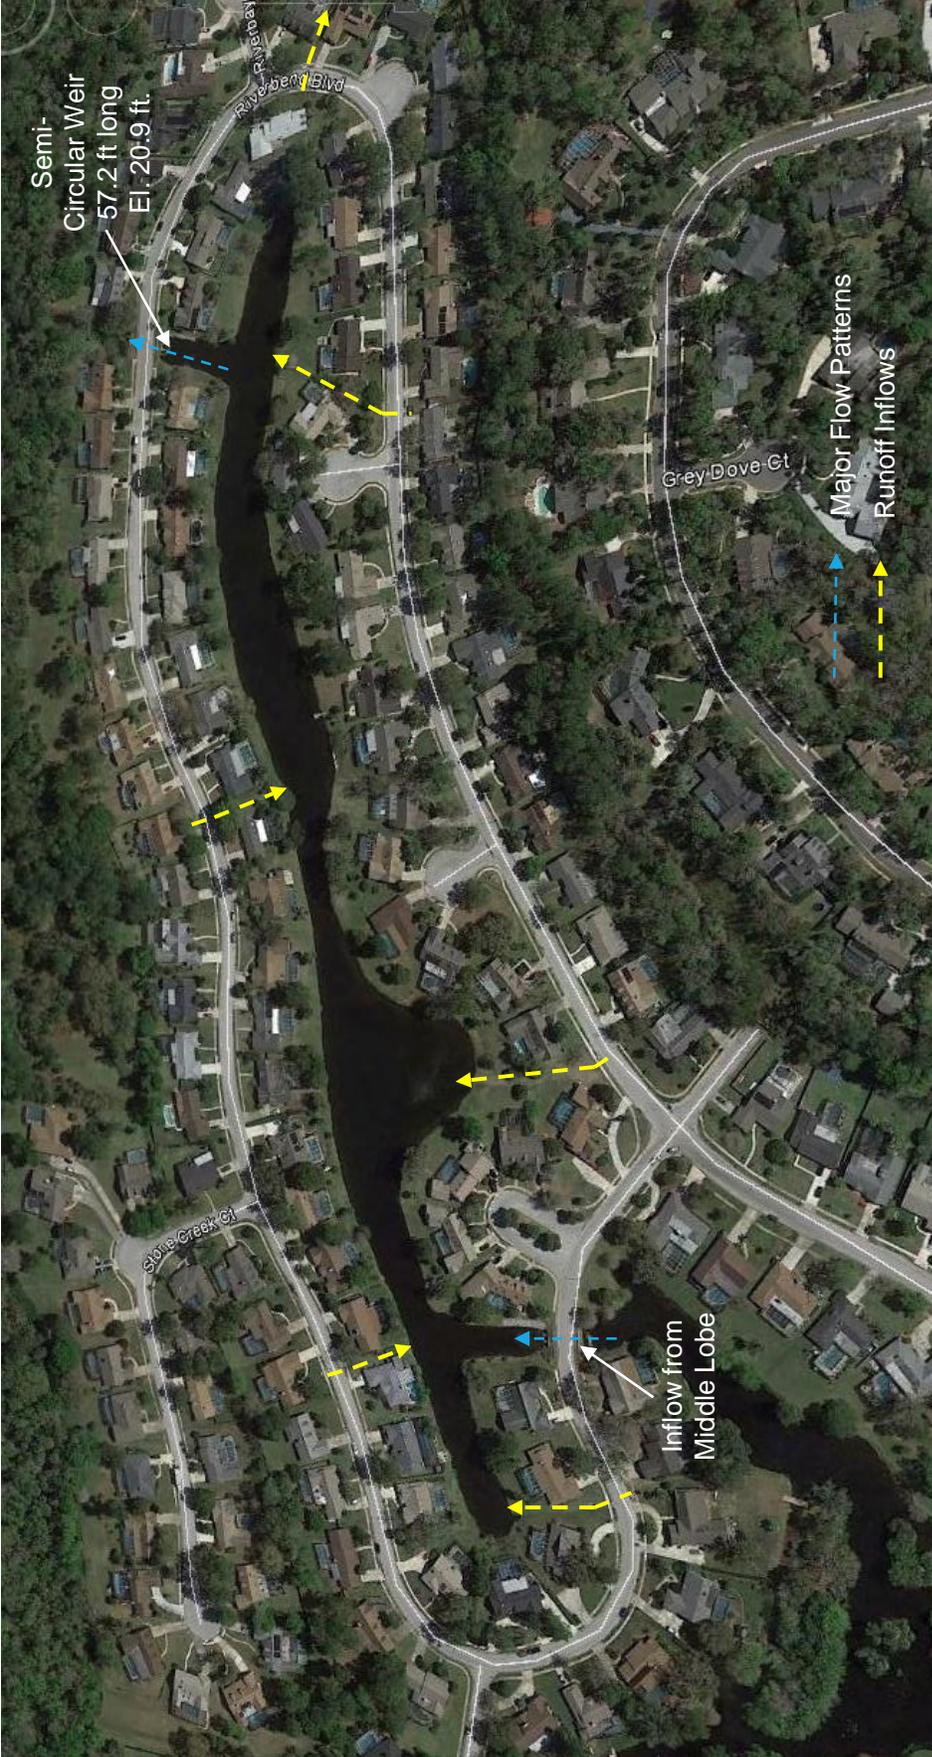
Figure 1-4. Significant Hydrologic Inputs and Losses to the Lower Lobe.

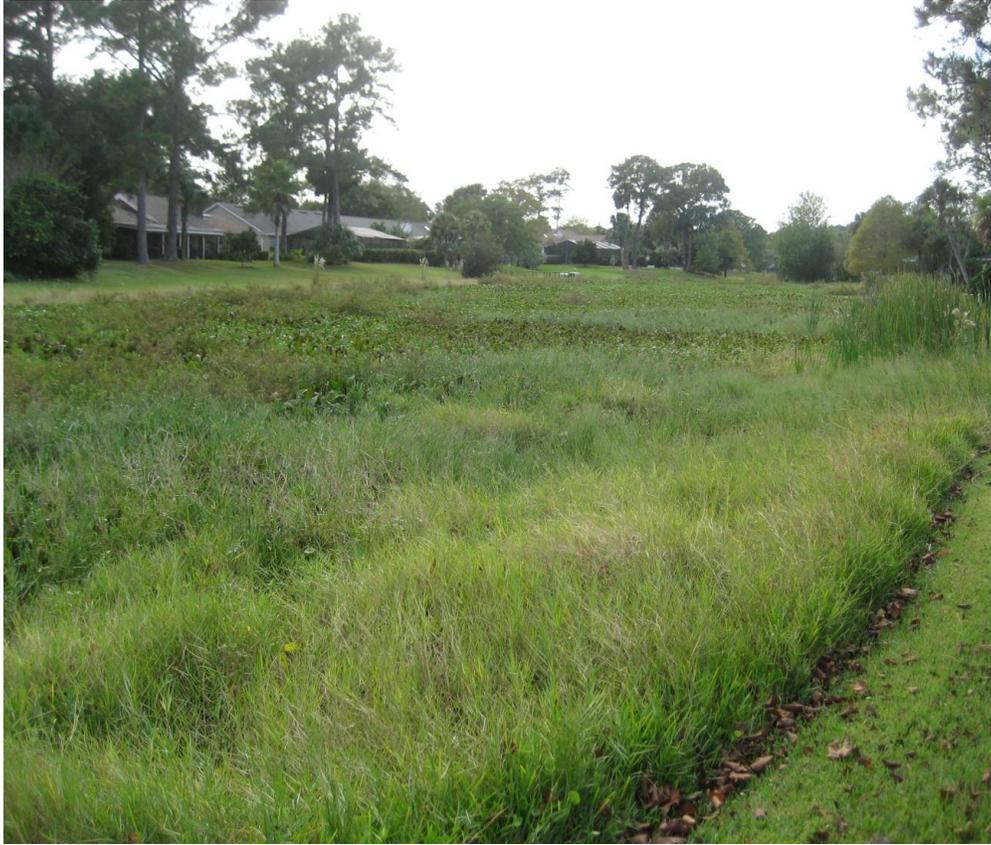
Figure 1-6. Photograph of the Lower Lobe During 2012.

For the past several years, Seminole County has conducted ongoing efforts to control the excessive growth of emergent vegetation and Lyngbya in lower Sweetwater Cove. A photograph of a portion of the lower lobe during 2012 is given on Figure 1-6. At that time, the lower lobe had become almost completely covered with emergent aquatic vegetation with few remaining areas of open water. Based upon concerns voiced by residents, Seminole County undertook a project to excavate and remove the existing nuisance and exotic emergent vegetation and deepen portions of the lower lobe to reduce the opportunity for recolonization of the emergent vegetation.

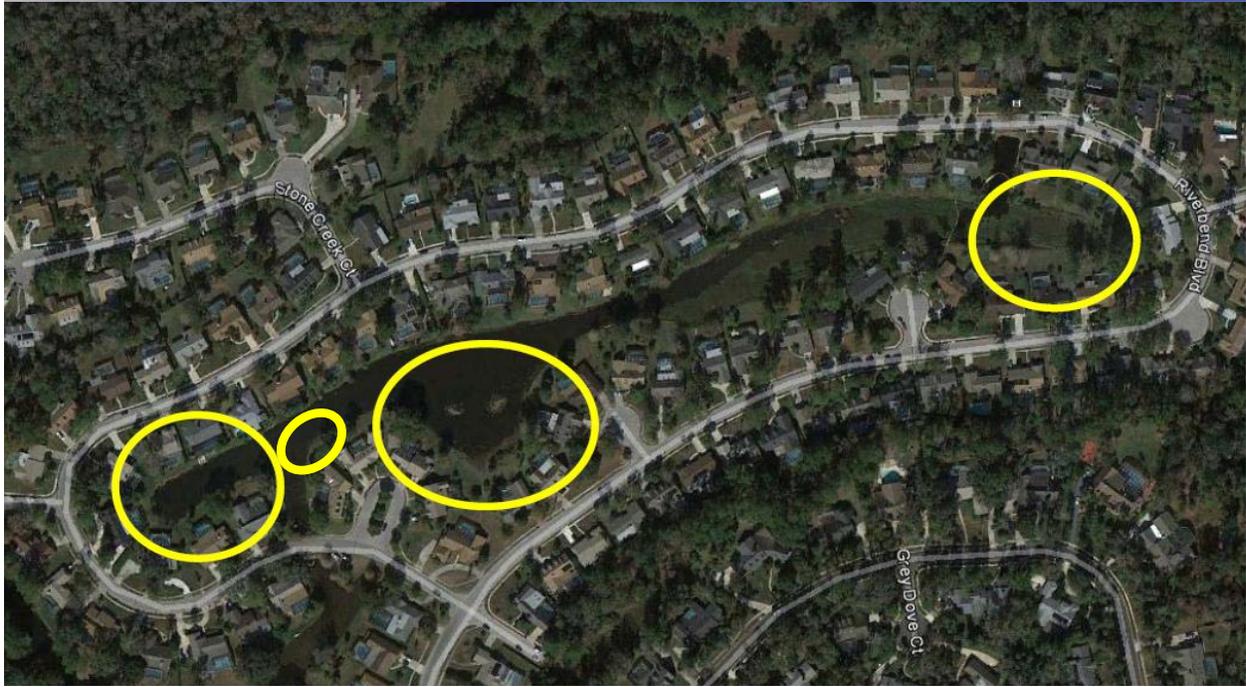
Figure 1-7. Approximate Areas for Selective Excavation.

Construction activities were initiated during July 2013 and completed in December 2013. Areas identified for selective excavation and deepening of the water column are illustrated on Figure 1-7 and include the extreme eastern and western portions of the lower lobe along with the small cove located on the south side of the lower lobe. Photographs of excavation activities in the lower lobe are illustrated on Figure 1-8, with a photograph of the “spyder” excavation machine shown on Figure 1-8a and the lower lobe during excavation activities shown on Figure 1-8b. A photograph of the lower lobe following excavation during 2014 is given on Figure 1-9. The excavation project was successful in converting the lower lobe from a system dominated by emergent nuisance/exotic vegetation to an open water system.

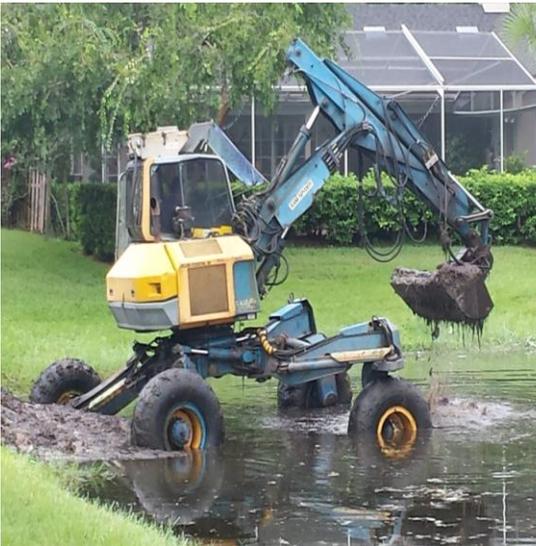
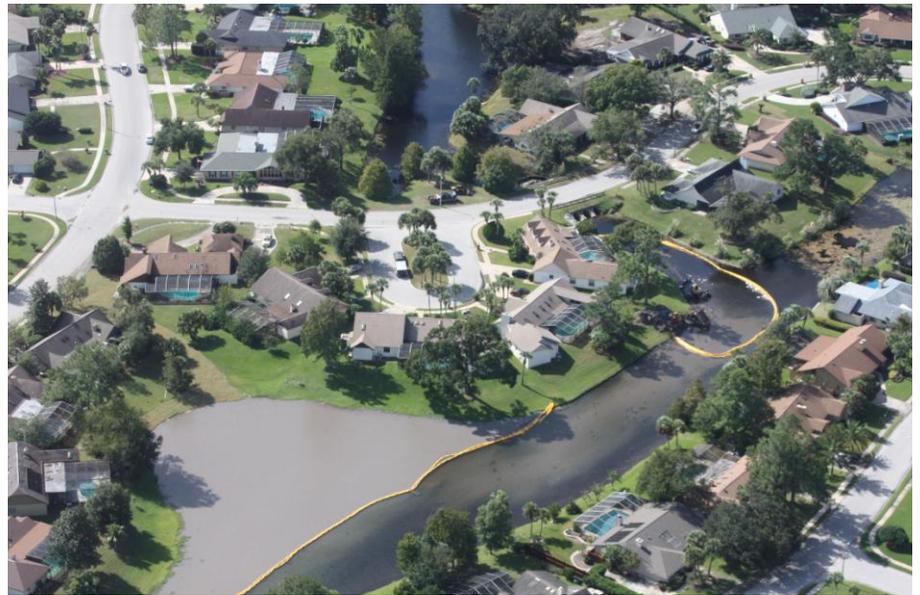
Figure 1-8. Excavation Activities in the Lower Lobe.

a. Photo of Spyder excavation machine

b. Lower lobe during excavation activities

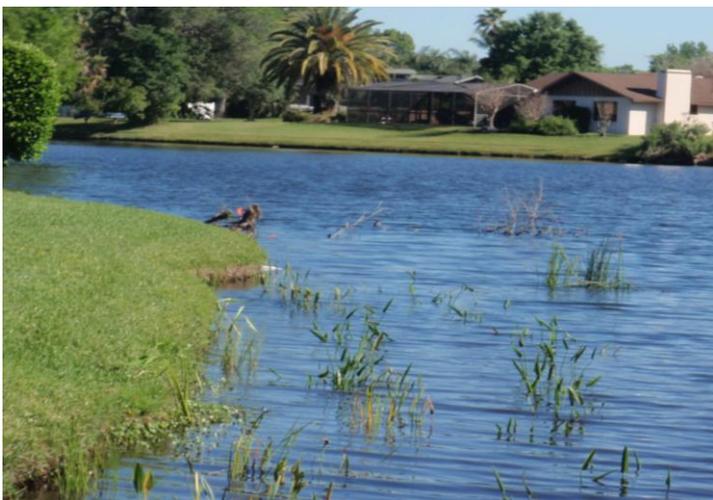
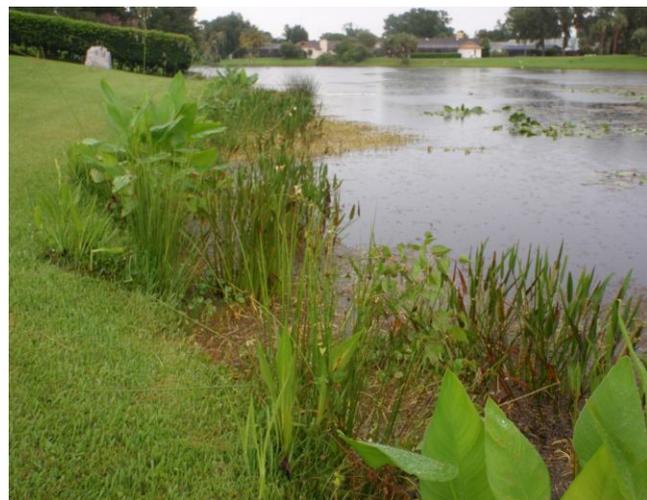
Figure 1-10. Aquatic Plantings in Lower Sweetwater Cove.

After completion of the vegetation removal and excavation activities in the lower lobe, Seminole County also conducted replanting of the emergent littoral zone vegetation along selected portions of the shoreline. Shoreline vegetation is an essential part of any healthy lake ecosystem. Vegetation provides many important functions, such as protection from erosion of shoreline areas and contributing to a diverse ecological community which is an important factor in maintaining good water quality characteristics. Shoreline vegetation also consumes nutrients, leaving fewer nutrients available for algal growth and reduces the formation and accumulation of organic muck. A photograph of a shoreline area following planting is given on Figure 1-10a, and a photograph of mature shoreline vegetation (approximately 12 months following installation) is given on Figure 1-10b.

a. Area following planting

b. Mature vegetation

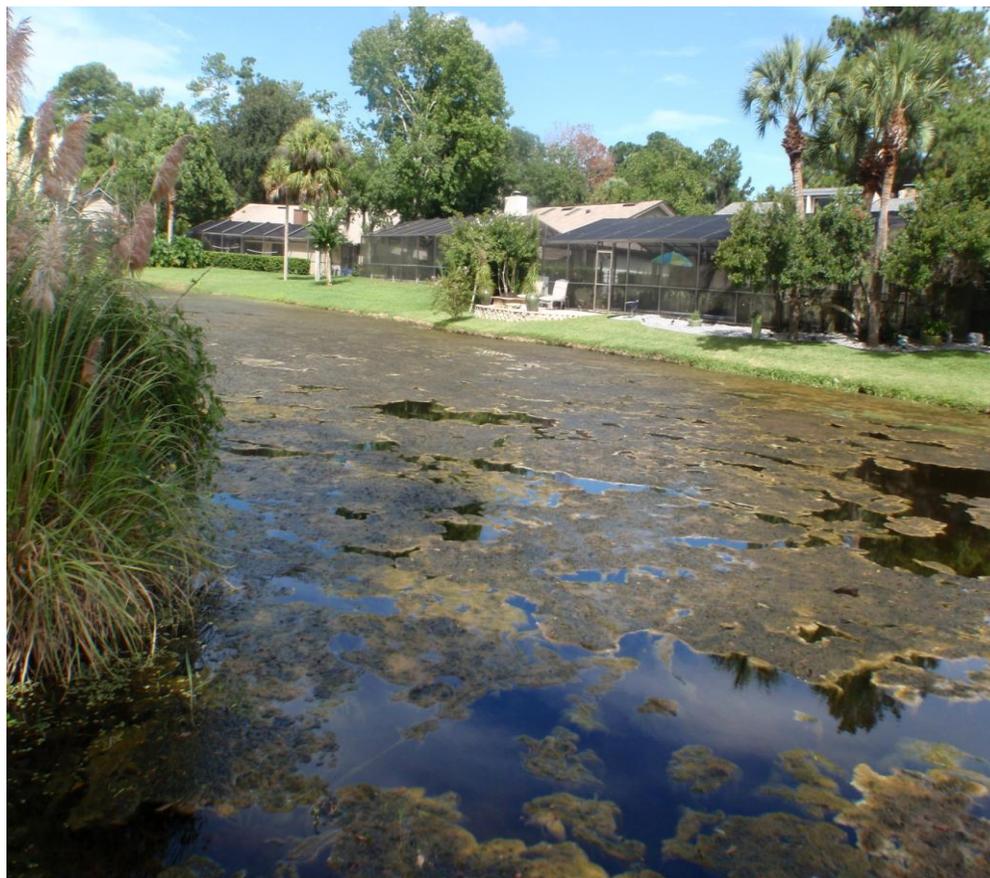
Figure 1-11. Photo of Lyngbya Growth in the Lower Lobe.

Shortly after completion of the previously described activities in the lower lobe, the lake began to experience patches of floating *Lyngbya* in isolated stagnant areas of the lake. At times, large areas of the lower lobe would become completely covered with floating *Lyngbya* which, in addition to being aesthetically unpleasing, isolated portions of the water column from atmospheric exchange. Photographs of floating *Lyngbya* in the lower lobe are given on Figure 1-11.

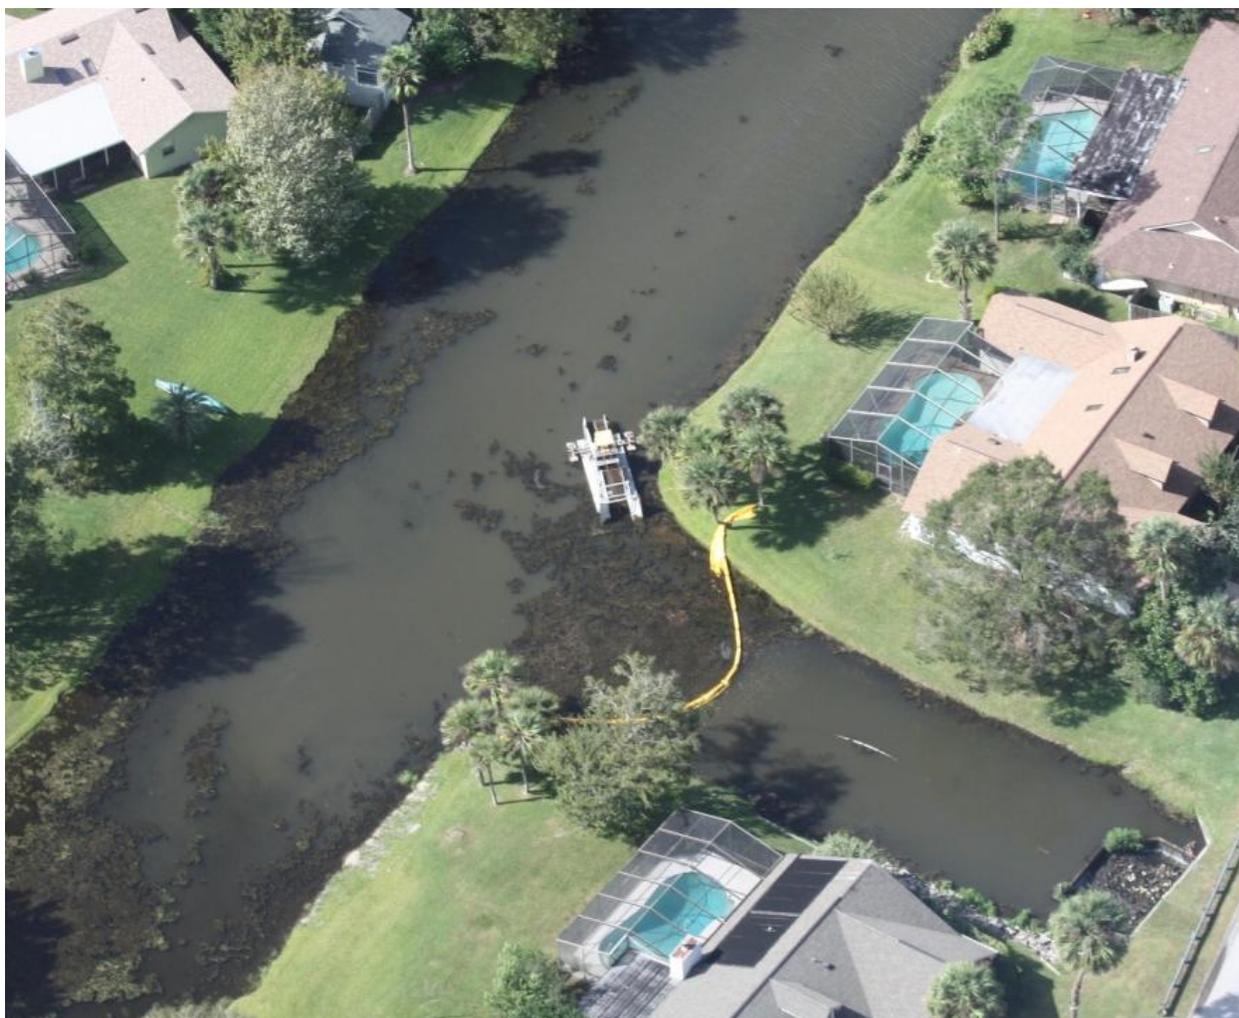
Figure 1-12. Harvester Used for Lyngbya Removal.

Seminole County has made multiple attempts to address the Lyngbya issue within the lower lobe. During December 2013, Seminole County attempted to remove the floating Lyngbya mats using an aquatic harvester typically used for removal of Hydrilla or other nuisance species. A photograph of the harvester used for Lyngbya removal in the lower lobe is given on Figure 1-12. The harvester was moderately successful in removing Lyngbya from the water surface, but significant areas of floating Lyngbya mats returned within a few months following removal. Seminole County has also attempted to control the growth of Lyngbya using bi-monthly herbicide treatments as well as using an application protocol developed by the Florida Wildlife Commission (FWC). A more detailed discussion of attempts to control algae growth using the FWC protocol is given in a subsequent section.

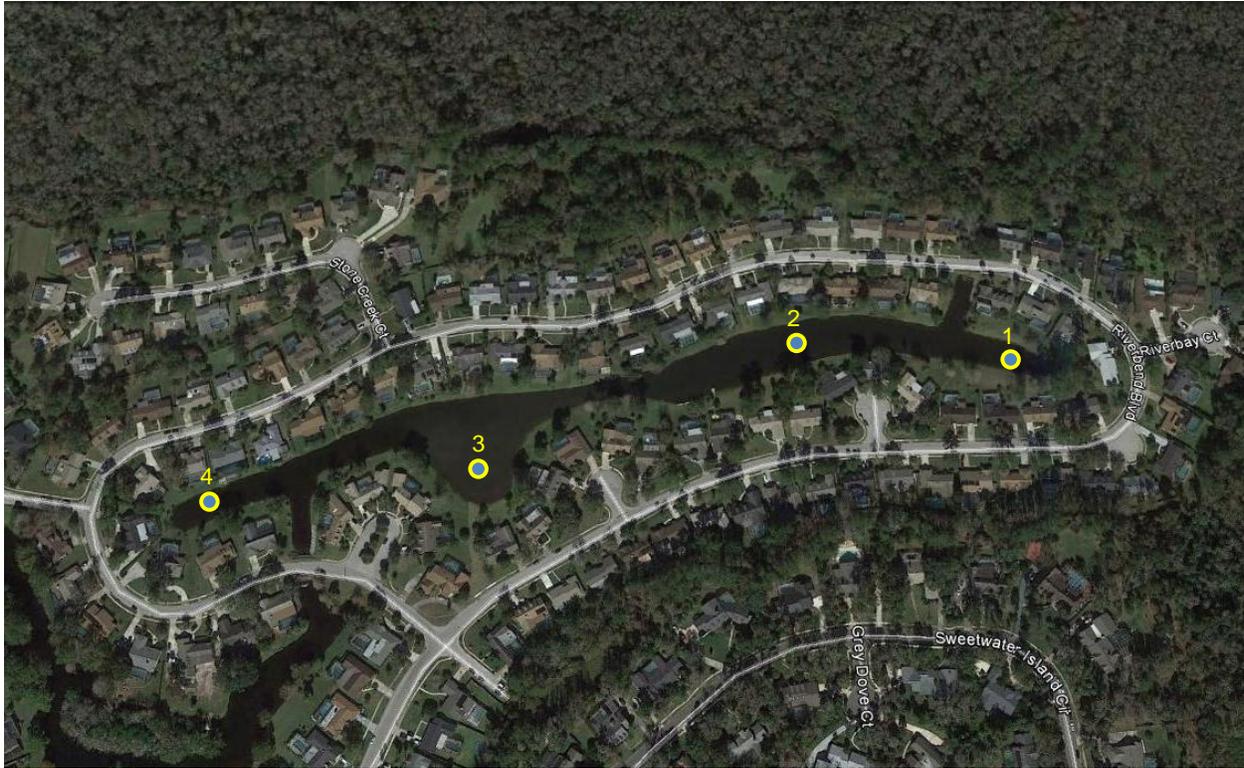
Figure 2-1. Water Quality Monitoring Sites in Lower Sweetwater Cove.

During each monitoring event, vertical profiles of pH, temperature, conductivity, dissolved oxygen, ORP, and turbidity were conducted at each site. Field measurements were collected at water depths of 0.25 m and at 0.5 m, and at 0.5 m intervals to the bottom at each site. All field measurements were performed using Hydrolab Data Sonde H2O and Data Sonde 4a units. A measurement of Secchi disk depth was also performed at each site.
