SWEETWATER COVE LAKE LYNGBYA NUTRIENT SOURCE EVALUATION

Final Report – December 2015

Seminole County, Florida

**Environmental Research & Design, Inc.
Harvey H. Harper, Ph.D., P.E. – Project Director
3419 Trentwood Blvd., Suite 102
Belle Isle (Orlando), FL 32812-4864
407-855-9465**

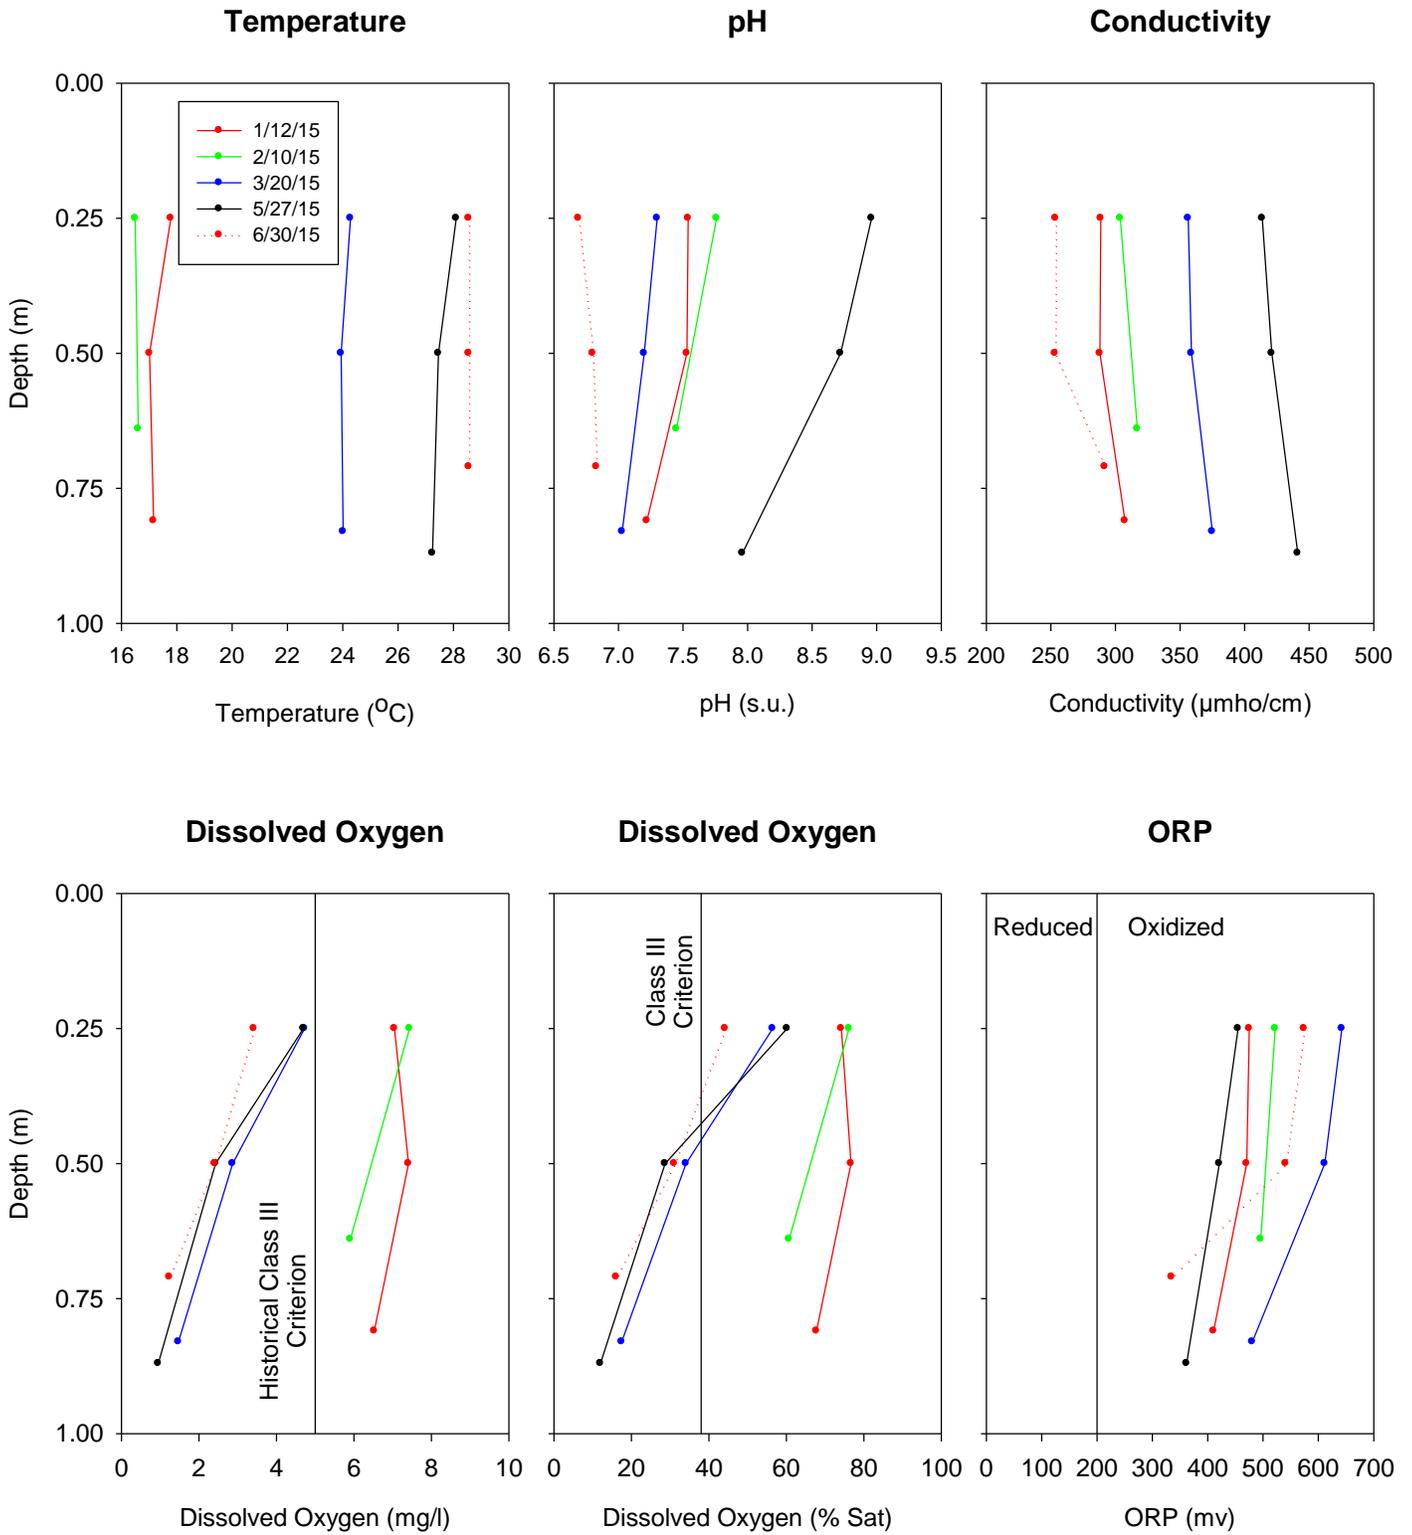
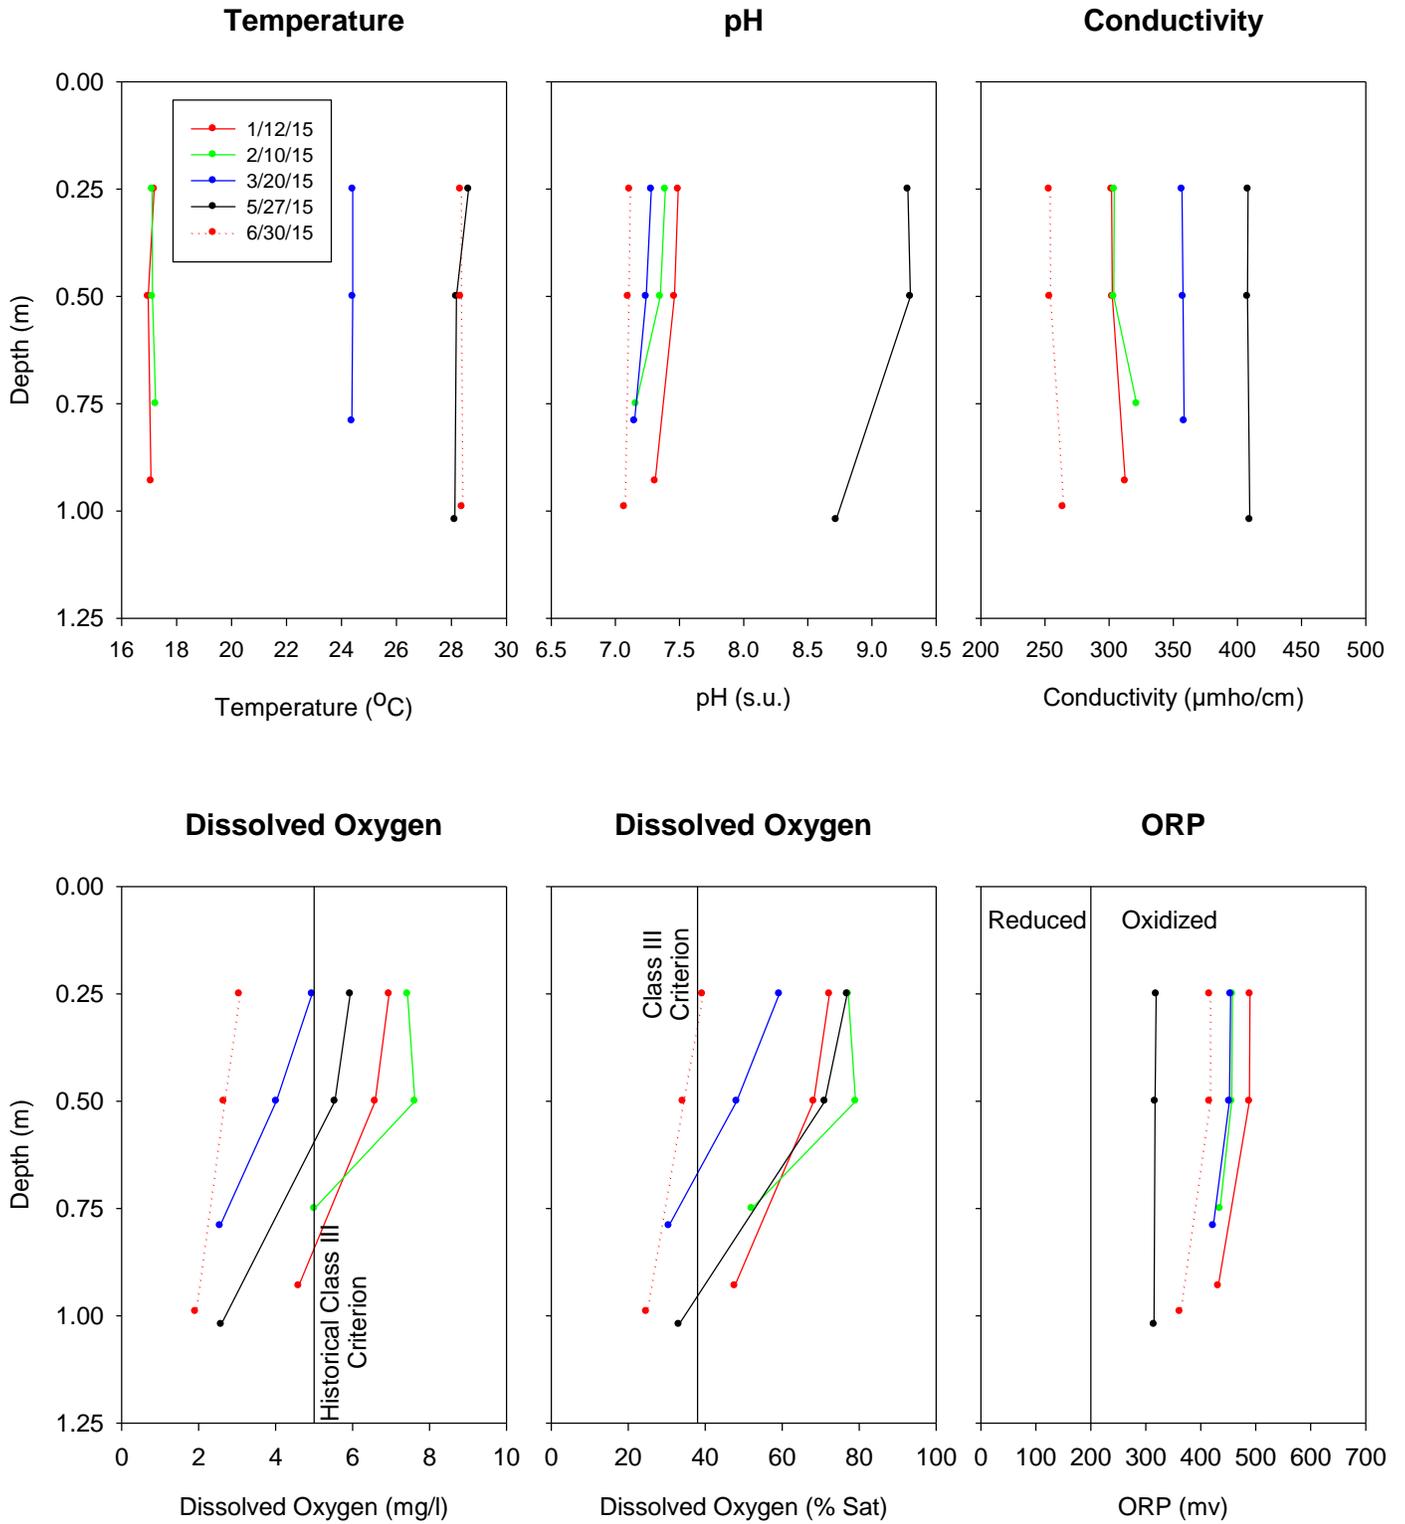
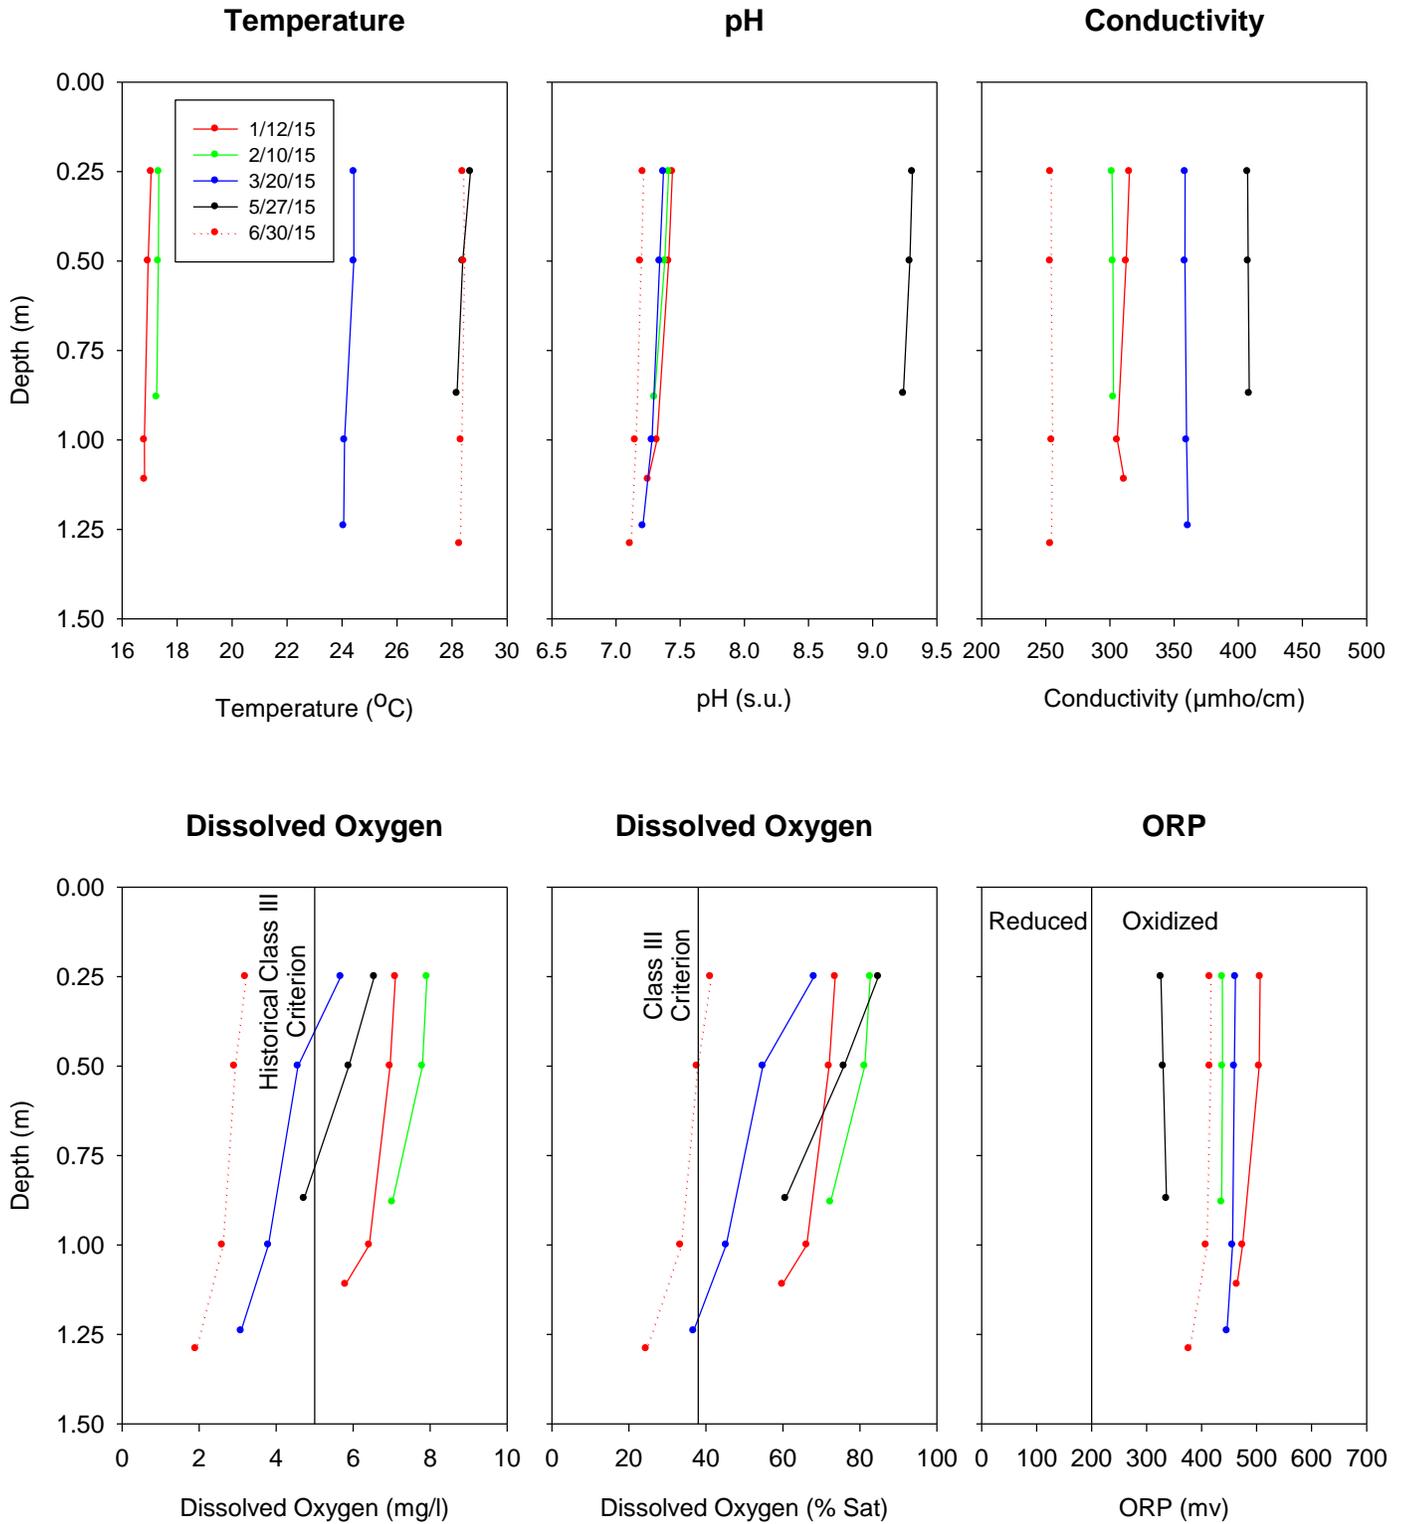
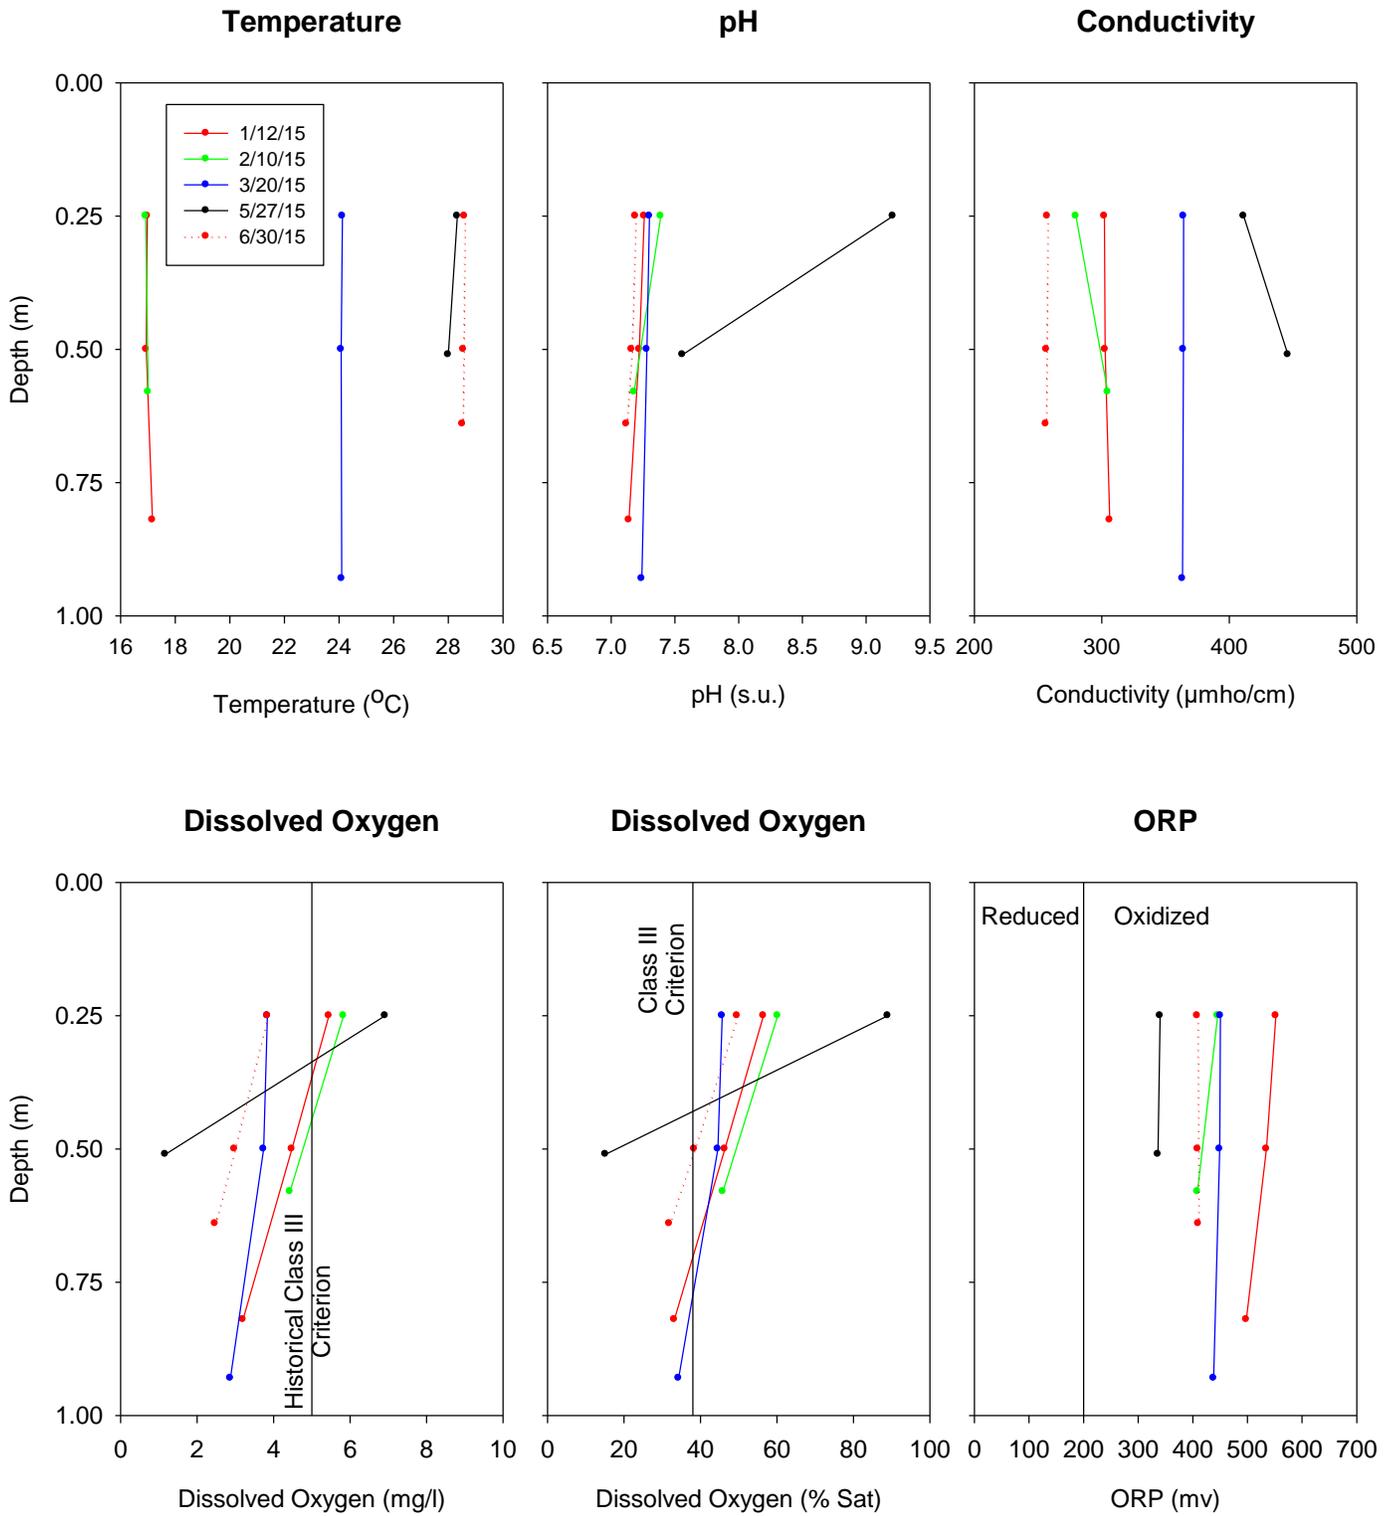
Figure 2-2. Vertical Field Profiles Collected at Site 1 in Lower Sweetwater Cove from January-June 2015.

Figure 2-3. Vertical Field Profiles Collected at Site 2 in Lower Sweetwater Cove from January-June 2015.

Figure 2-4. Vertical Field Profiles Collected at Site 3 in Lower Sweetwater Cove from January-June 2015.

Figure 2-5. Vertical Field Profiles Collected at Site 4 in Lower Sweetwater Cove from January-June 2015.

Graphical summaries of vertical field profiles of temperature, pH, conductivity, dissolved oxygen, and oxidation-reduction potential (ORP) measured at each of the four monitoring sites in lower Sweetwater Cove are given in Figures 2-2 through 2-5, for Sites 1, 2, 3, and 4, respectively. In general, relatively uniform temperature measurements were observed at each of the four monitoring locations within lower Sweetwater Cove during each of the five surface water monitoring events. The observed isograde profiles for temperature are likely related to the shallow water column within the lake. Temperature differences between top and bottom measurements at each of the four sites were typically less than 0.5°C during most events. No evidence of significant thermal stratification was observed at any of the monitoring sites during any of the events. As indicated on Table 2-2, mean water column temperatures at the four surface water monitoring sites were within 0.7°C during most events, suggesting relatively minimal horizontal variability in temperature.

Measured pH values in lower Sweetwater Cove were highly variable, with surface (0.25 m) pH measurements ranging from 6.69-9.28 during the 6-month field monitoring program. With the exception of Site 1, measured pH profiles were virtually identical at each of the four monitoring sites during the months of January, February, March, and June, with surface pH measurements ranging from approximately 7.0-7.5 during this period. However, a somewhat larger range of surface pH values was observed during January, February, March, and June at Site 1, with surface measurements ranging from approximately 6.6-7.6. A slight decrease in pH was observed with increasing water depth during most events, although differences between top and bottom pH measurements were typically less than 0.2 units.

Measurements of pH conducted during May 2015 were substantially higher in value at each of the four monitoring sites, with surface measurements on this date ranging from 8.96-9.31. Measured pH values in this range are often indicative of a high level of algal production. Decreases in pH with increasing water depth were more significant during the May 2015 event than observed for the remaining events, with pH differences between top and bottom measurements ranging from 0.5-1.0 unit or more at most sites. Mean water column pH values between the individual sites were typically within 0.5 units, providing evidence of minimal horizontal variability in pH. Overall, with the exception of the June monitoring event at Site 1, surface water within Sweetwater Cove was characterized by alkaline conditions.

The standard for dissolved oxygen in Class III freshwater systems (defined as waterbodies used for recreation and wildlife) has historically been 5 mg/l, and this concentration is indicated on Figures 2-2 through 2-5 for reference purposes. Based upon this historical criterion, violations of the 5 mg/l standard would have occurred during 3 of the 5 events at Site 1, 2 of the 5 events at Site 2, 1 of the 5 events at Site 3, and 2 of the 5 events at Site 4. However, FDEP has recently adopted a revised dissolved oxygen criterion which is based upon oxygen saturation rather than a specific concentration. The revised Class III criterion for dissolved oxygen saturation in freshwater systems requires that the daily average percent dissolved oxygen saturation shall not be below 38% in the top 2 m of a waterbody in more than 10% of the locations monitored. Based upon this revised dissolved oxygen criterion, and the mean water column saturation values summarized in Table 2-2, dissolved oxygen in lower Sweetwater Cove appears to have violated the oxygen saturation criterion during 3 of the 5 events at Site 1, 1 of the 5 events at Site 2, 1 of the 5 events at Site 3, and 2 of the 5 events at Site 4. Violations of the current Class III criterion were observed primarily at Site 1 which is located in an isolated cove on the east end of lower Sweetwater Cove. Overall, with the exception of Site 1, the water column in lower Sweetwater Cove appears to contain adequate dissolved oxygen to support the existing wildlife within the lake.

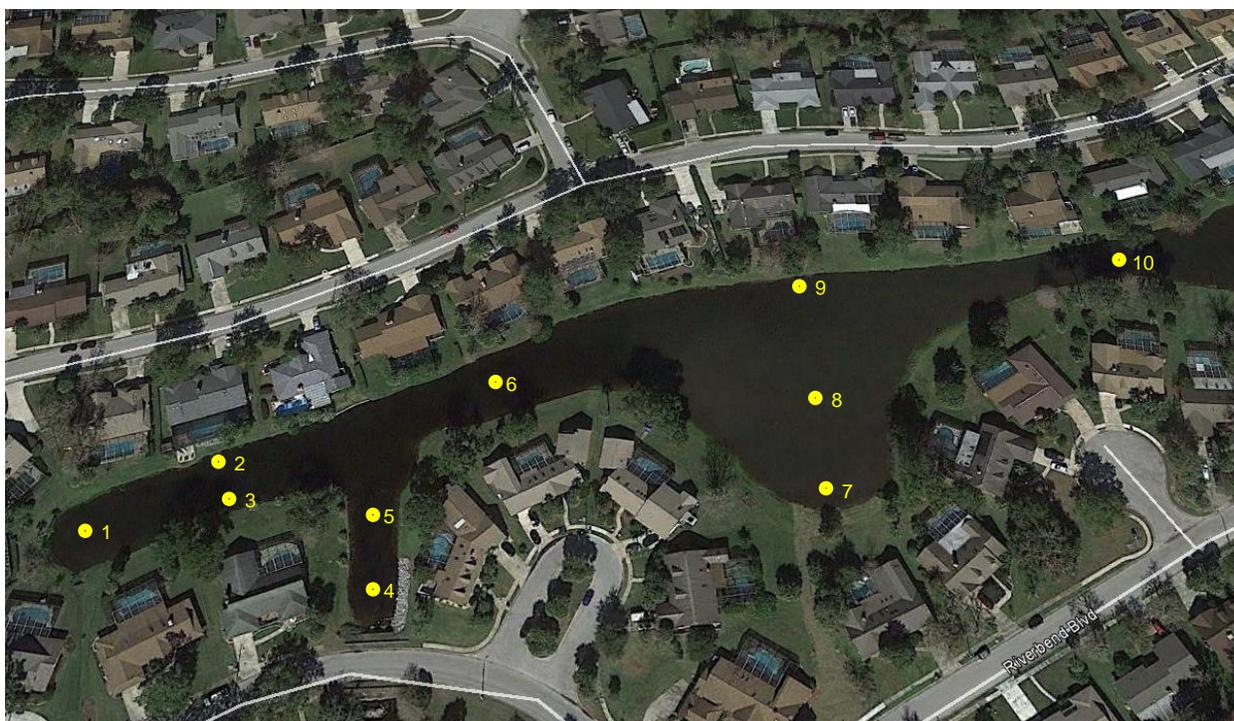
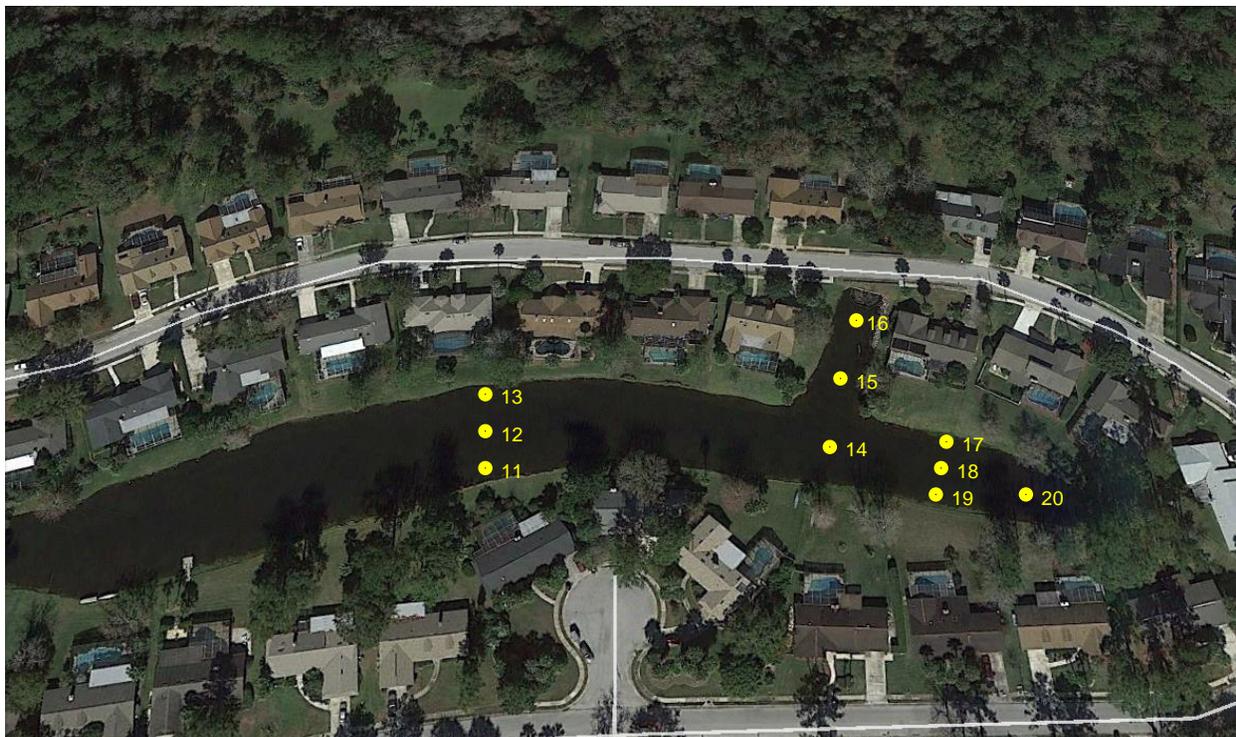
Figure 3-1. Locations of Sediment Monitoring Sites in the West Half of the Lower Lobe of Sweetwater Cove Lake.

Figure 3-2. Locations of Sediment Monitoring Sites in the East Half of the Lower Lobe of Sweetwater Cove Lake.

Sediment core samples were collected by ERD in the lower lobe of Sweetwater Cove Lake to evaluate the characteristics of existing sediments and potential impacts on water quality within the lake. Sediment core samples were collected at 20 separate locations within the lower lobe on January 7, 2015. Locations of sediment monitoring sites in the west half of the lower lobe of Sweetwater Cove Lake are indicated on Figure 3-1, with monitoring sites in the east half indicated on Figure 3-2. Based on the lake surface area of 4.55 acres, sediment samples were collected at an average rate of one sample for every 0.46 acres of lake area.

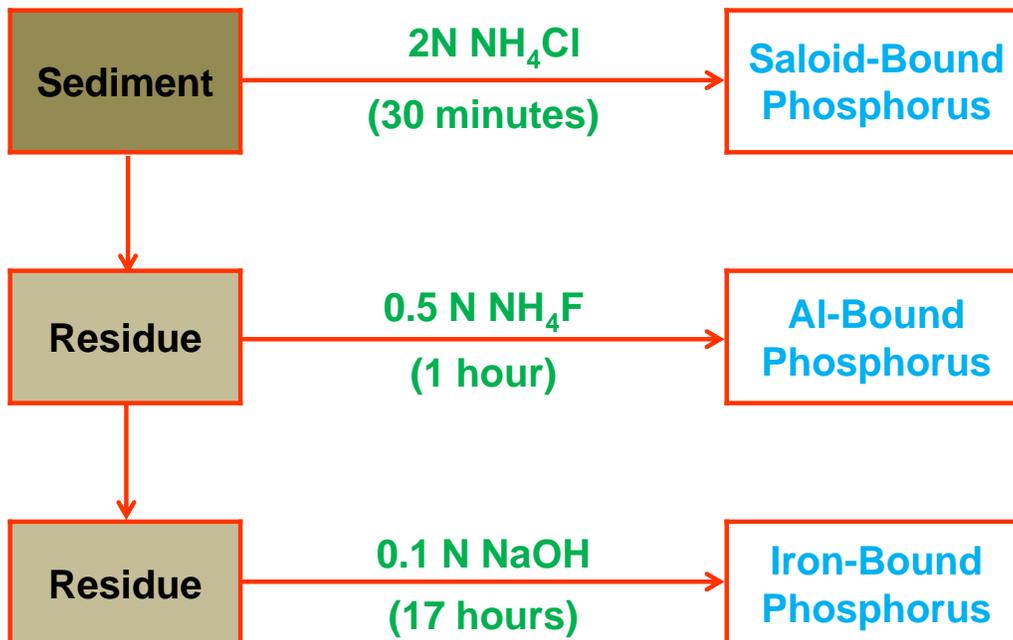
Figure 3-3. Schematic of Chang and Jackson Speciation Procedure for Evaluating Soil Phosphorus Bonding.

For purposes of evaluating release potential, ERD typically assumes that potentially available inorganic phosphorus in soils/sediments, particularly those which exhibit a significant potential to develop reduced conditions below the sediment-water interface, is represented by the sum of the soluble inorganic phosphorus and easily exchangeable phosphorus fractions (collectively termed saloid-bound phosphorus), plus iron-bound phosphorus which can become solubilized under reduced conditions. Aluminum-bound phosphorus is generally considered to be unavailable in the pH range of approximately 5.5-7.5 under a wide range of redox conditions.

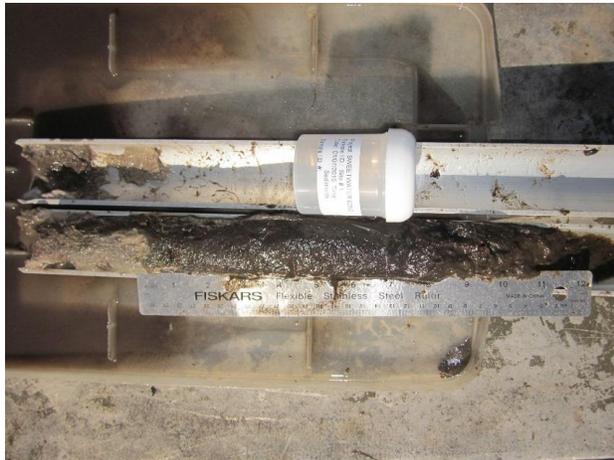
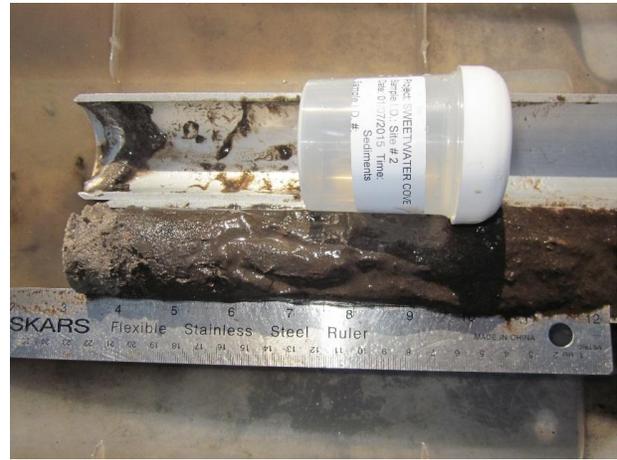
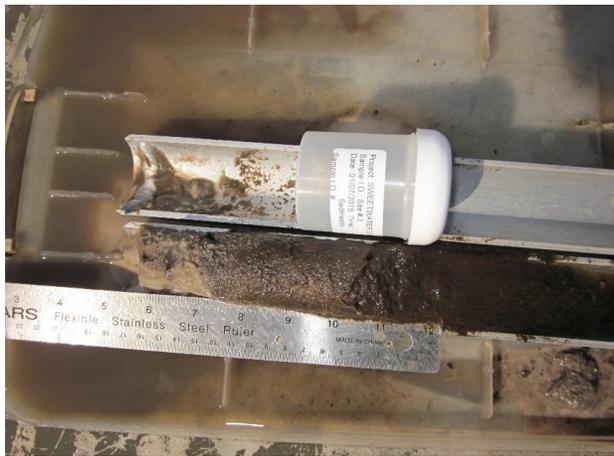
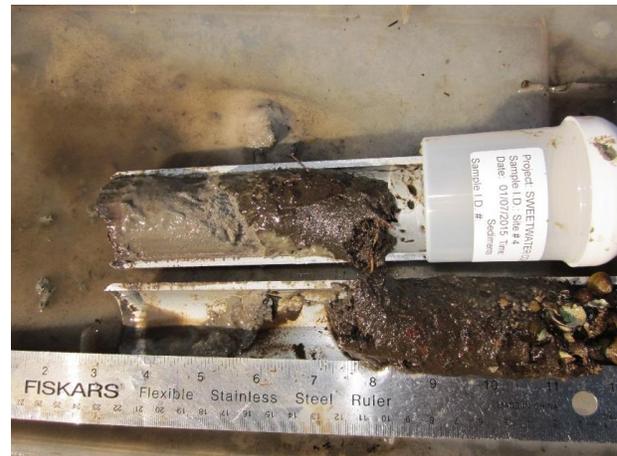
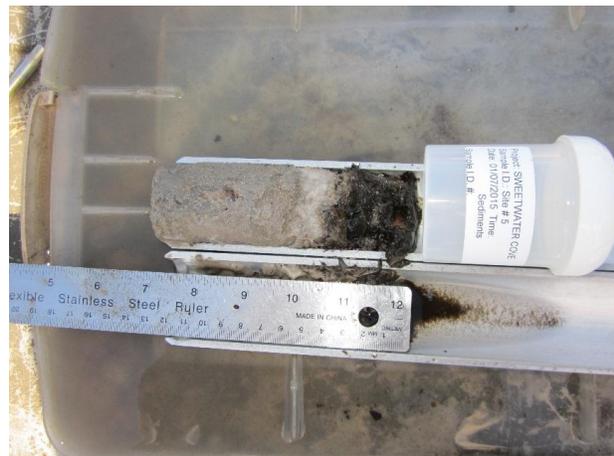
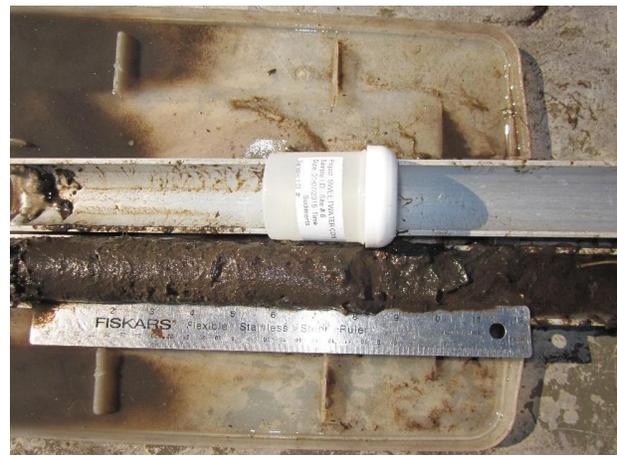
Figure 3-4. Photographs of Sediment Core Samples Collected in the Lower Lobe of Sweetwater Cove Lake on January 7, 2015.

Visual characteristics of sediment core samples were recorded for each of the 20 sediment samples collected in the lower lobe of Sweetwater Cove Lake on January 7, 2015. A summary of visual characteristics of sediment core samples is given in Table 3-2. In general, a surficial layer of unconsolidated organic muck was observed in the lower lobe at 18 of the 20 monitoring sites, with measured muck depths ranging from 3-41 cm. This unconsolidated surficial layer is comprised primarily of fresh organic material (such as dead algal cells) and detritus which has accumulated onto the bottom of the lake and is easily disturbed by wind action or boating activities. Consolidated organic muck, comprised of recalcitrant organic matter and commonly observed in urban lake sediments below the unconsolidated organic muck, was not observed in the lower lobe, possibly due to the age of the waterbody and periodic desiccation events. Layers beneath the organic muck consist of various types of light to brown fine sand which is the parent soil layer which forms the original lake bottom. Photographs of sediment characteristics in the lower lobe of Sweetwater Cove Lake are given in Figure 3-4. Evidence of iron deposits is visible in several of the core photographs.

SITE	TIME	LAYER (cm)	VISUAL APPEARANCE
1	11:53	0 – 25 25 - >41	Dark brown unconsolidated organic muck Fine brown sand with organics
2	11:46	0 – 16 16 - >22	Dark brown unconsolidated organic muck Fine brown sand with organics
3	11:40	0 – 3 3 – 17 17 - >19	Dark brown unconsolidated organic muck Fine brown sand with organics Light brown fine sand
4	11:34	0 – 15 15 - >31	Dark brown unconsolidated organic muck with detritus Fine brown sand with organics
5	11:26	0 – 3 3 - >12	Dark brown unconsolidated organic muck Fine brown sand with organics
6	11:18	0 – 29 > 29	Dark brown unconsolidated organic muck Light brown hard sand
7	11:10	0 – 13 13 - >21	Dark brown unconsolidated organic muck Fine brown sand with organics
8	11:04	0 – 4 4 - >13	Dark brown unconsolidated organic muck Fine brown sand with organics
9	10:58	0 – 2 2 - >21	Dark brown unconsolidated organic muck Fine brown sand with organics
10	10:51	0 – 18 18 - >26	Dark brown unconsolidated organic muck Light brown fine sand

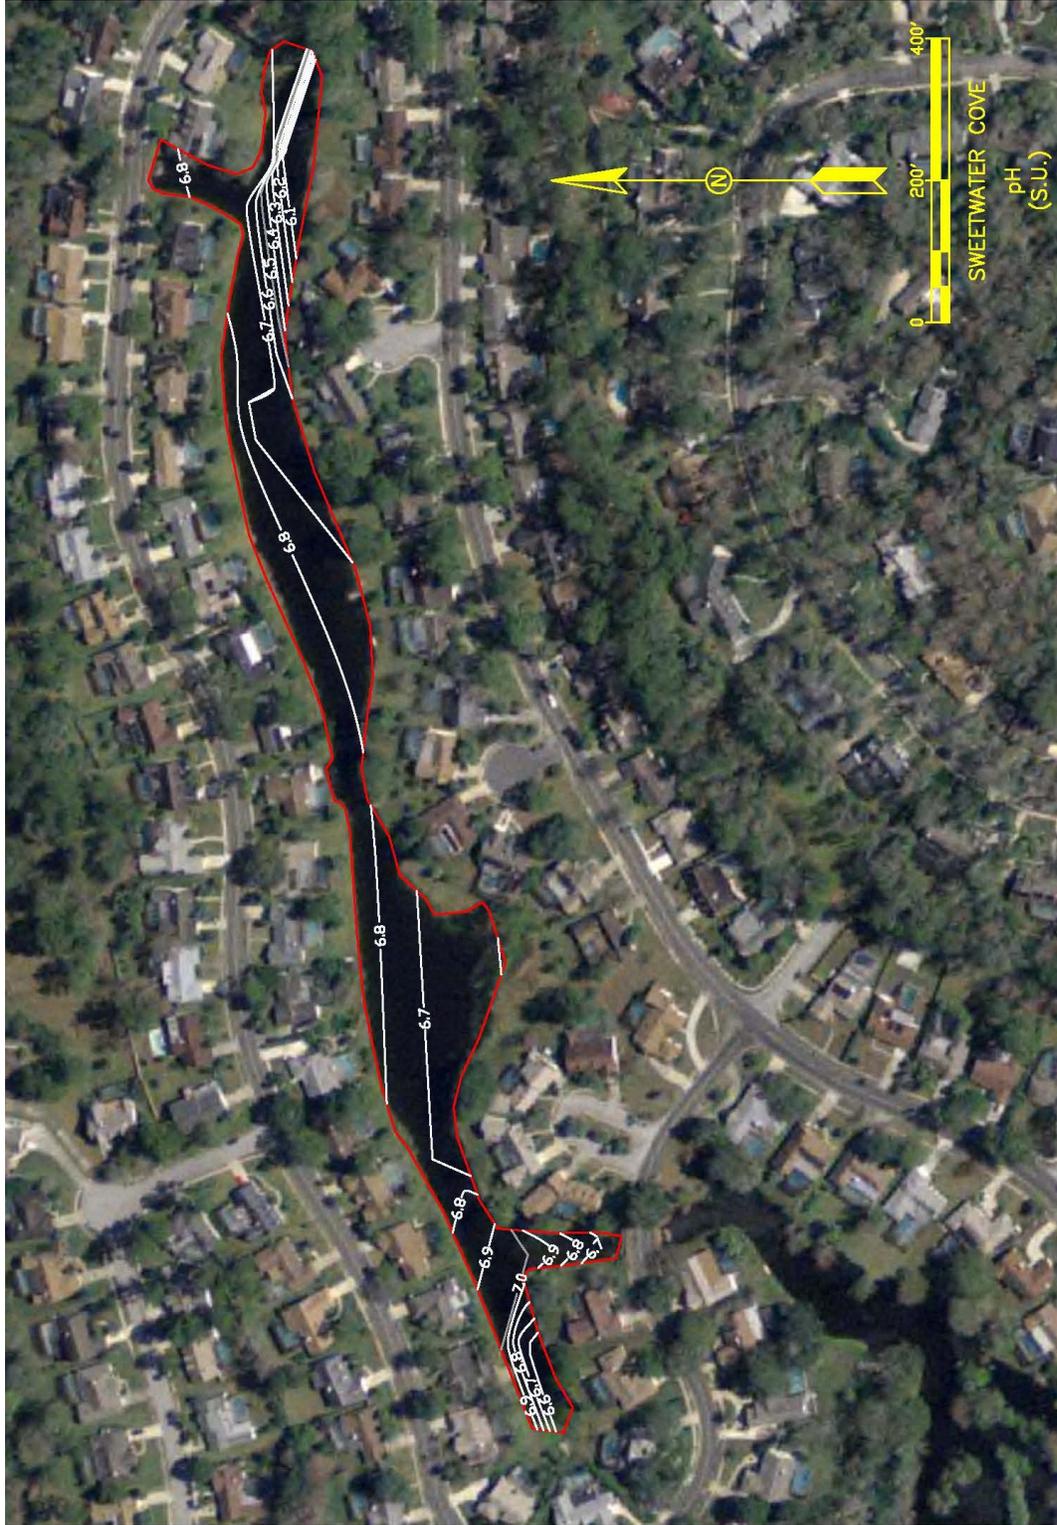
Figure 3-5. Isopleths of pH (s.u.) in the Top 10 cm of Sediments in the Lower Lobe of Sweetwater Cove Lake.

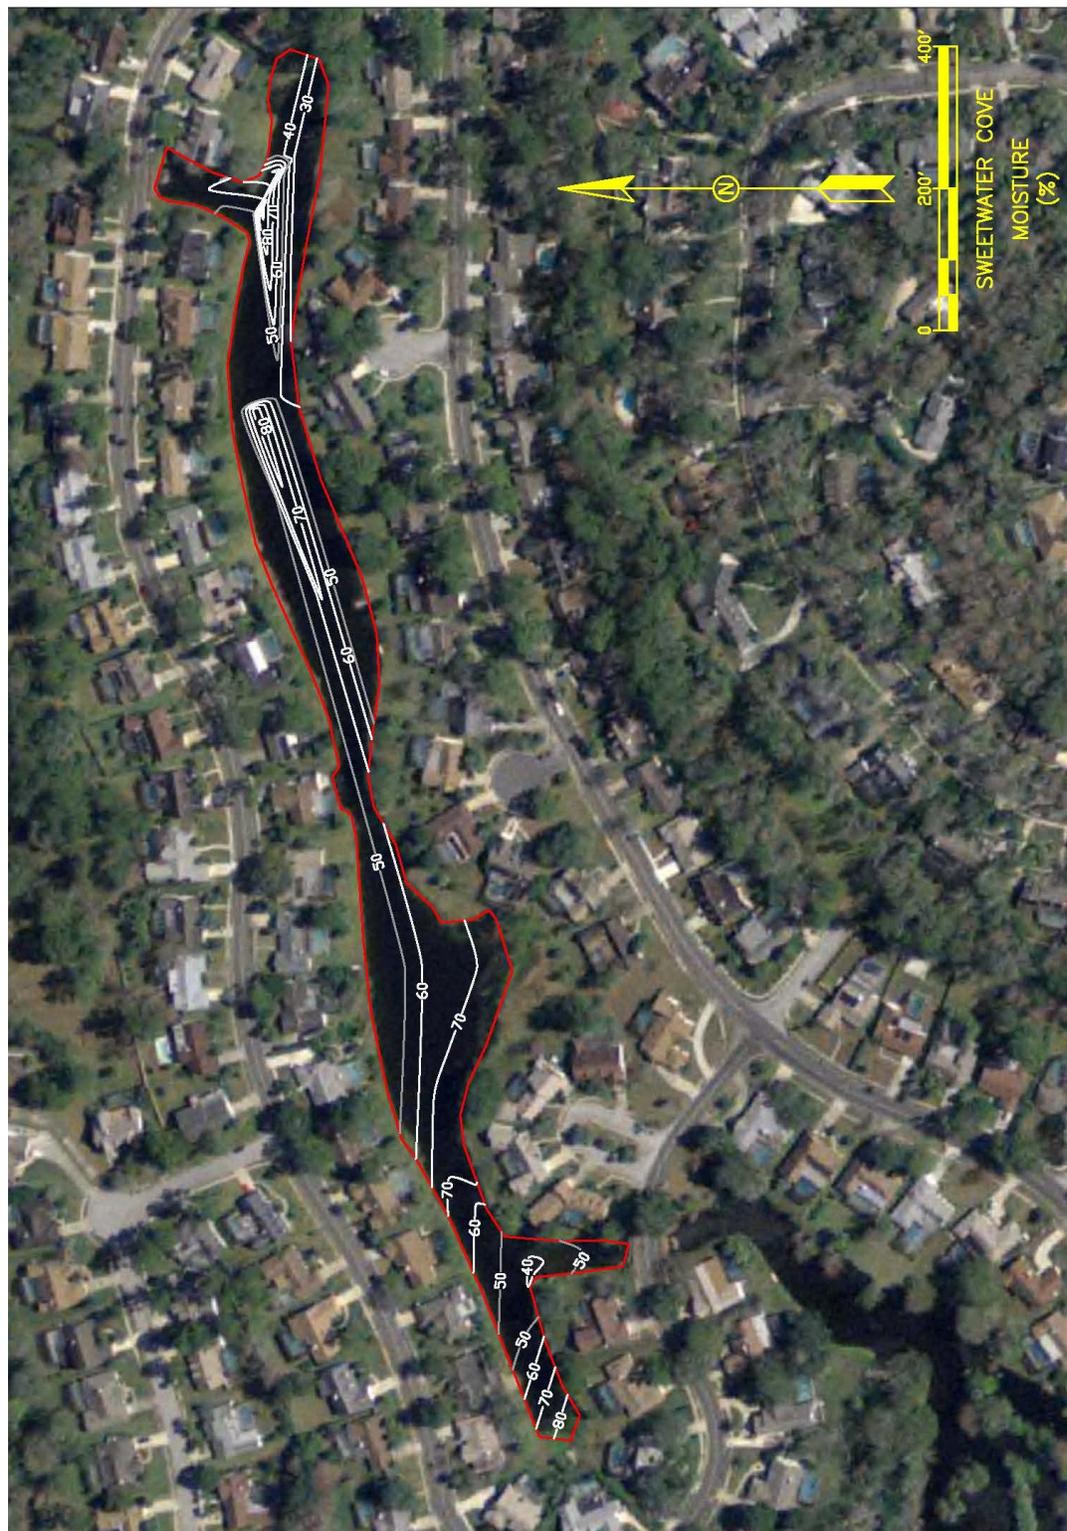
Figure 3-6. Isopleths of Moisture Content (%) in the Top 10 cm of Sediments in the Lower Lobe of Sweetwater Cove Lake.

Isopleths of sediment moisture content in the lower lobe sediments are illustrated in Figure 3-6 based upon the information provided in Table 3-3. Areas of elevated moisture content (> 50%) are present throughout most of the lower lobe. Sediment moisture contents in excess of 50% are often indicative of highly organic sediments, while moisture contents less than 50% reflect mixtures of sand and muck. Mixtures of muck and sand are located primarily in the primary inflow canal and in the eastern end of the lake.
