SWEETWATER COVE LAKE LYNGBYA NUTRIENT SOURCE EVALUATION

Final Report – December 2015

Seminole County, Florida

**Environmental Research & Design, Inc.
Harvey H. Harper, Ph.D., P.E. – Project Director
3419 Trentwood Blvd., Suite 102
Belle Isle (Orlando), FL 32812-4864
407-855-9465**

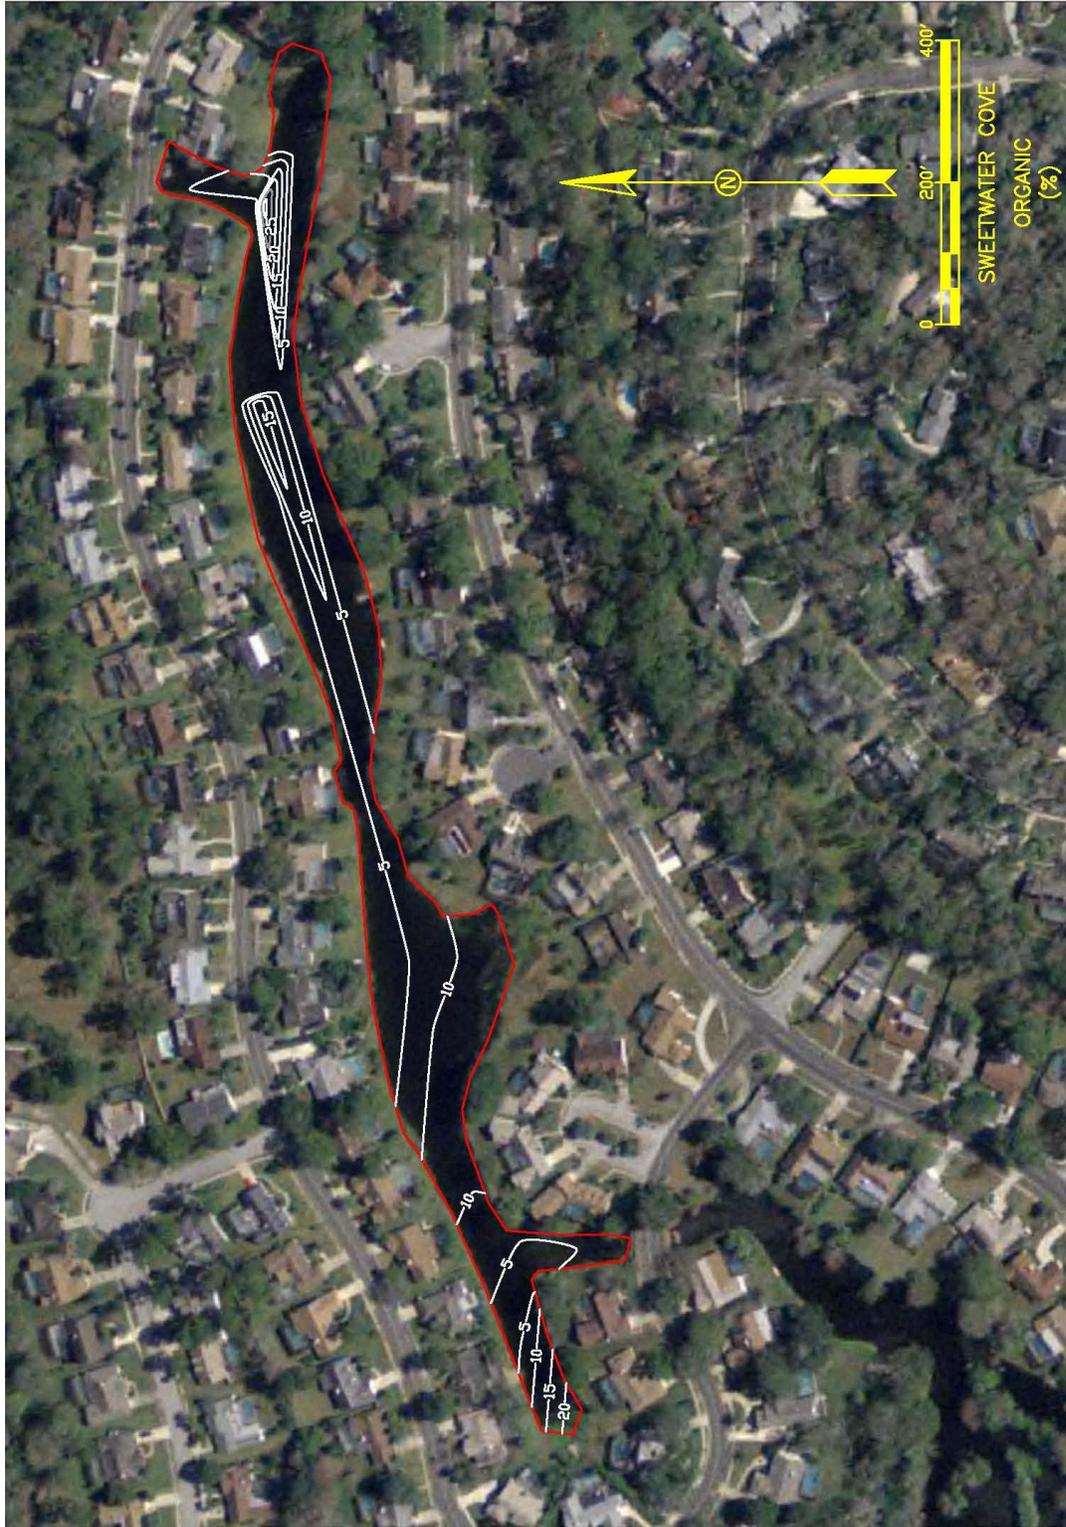
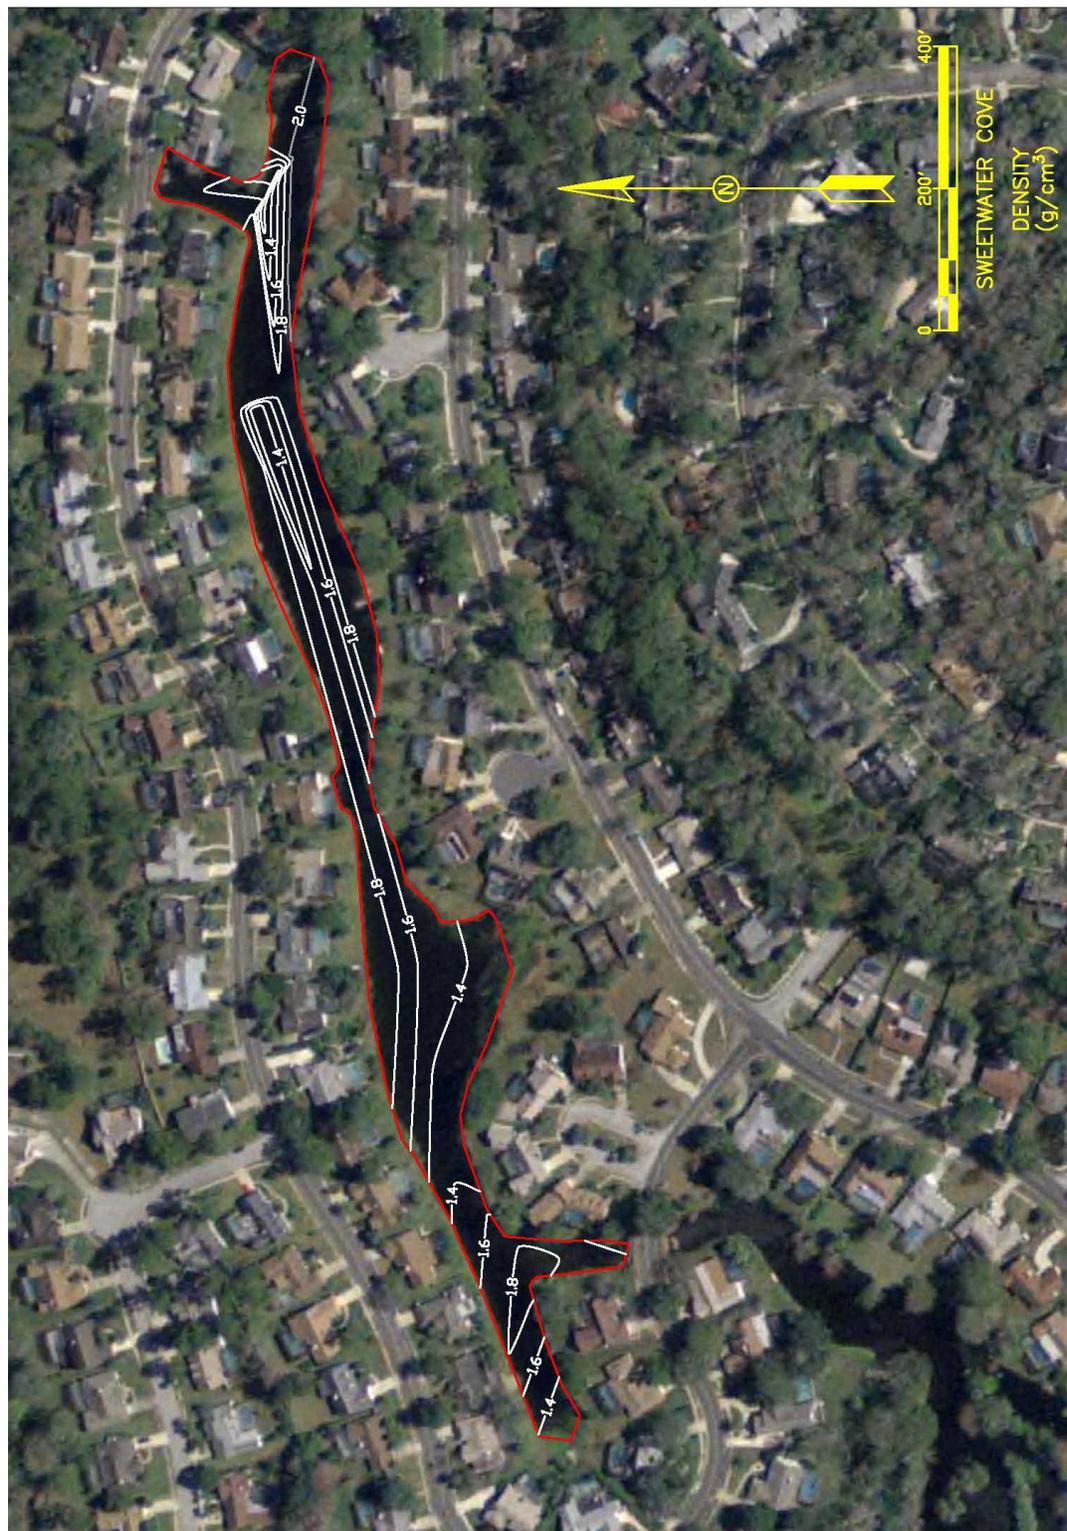
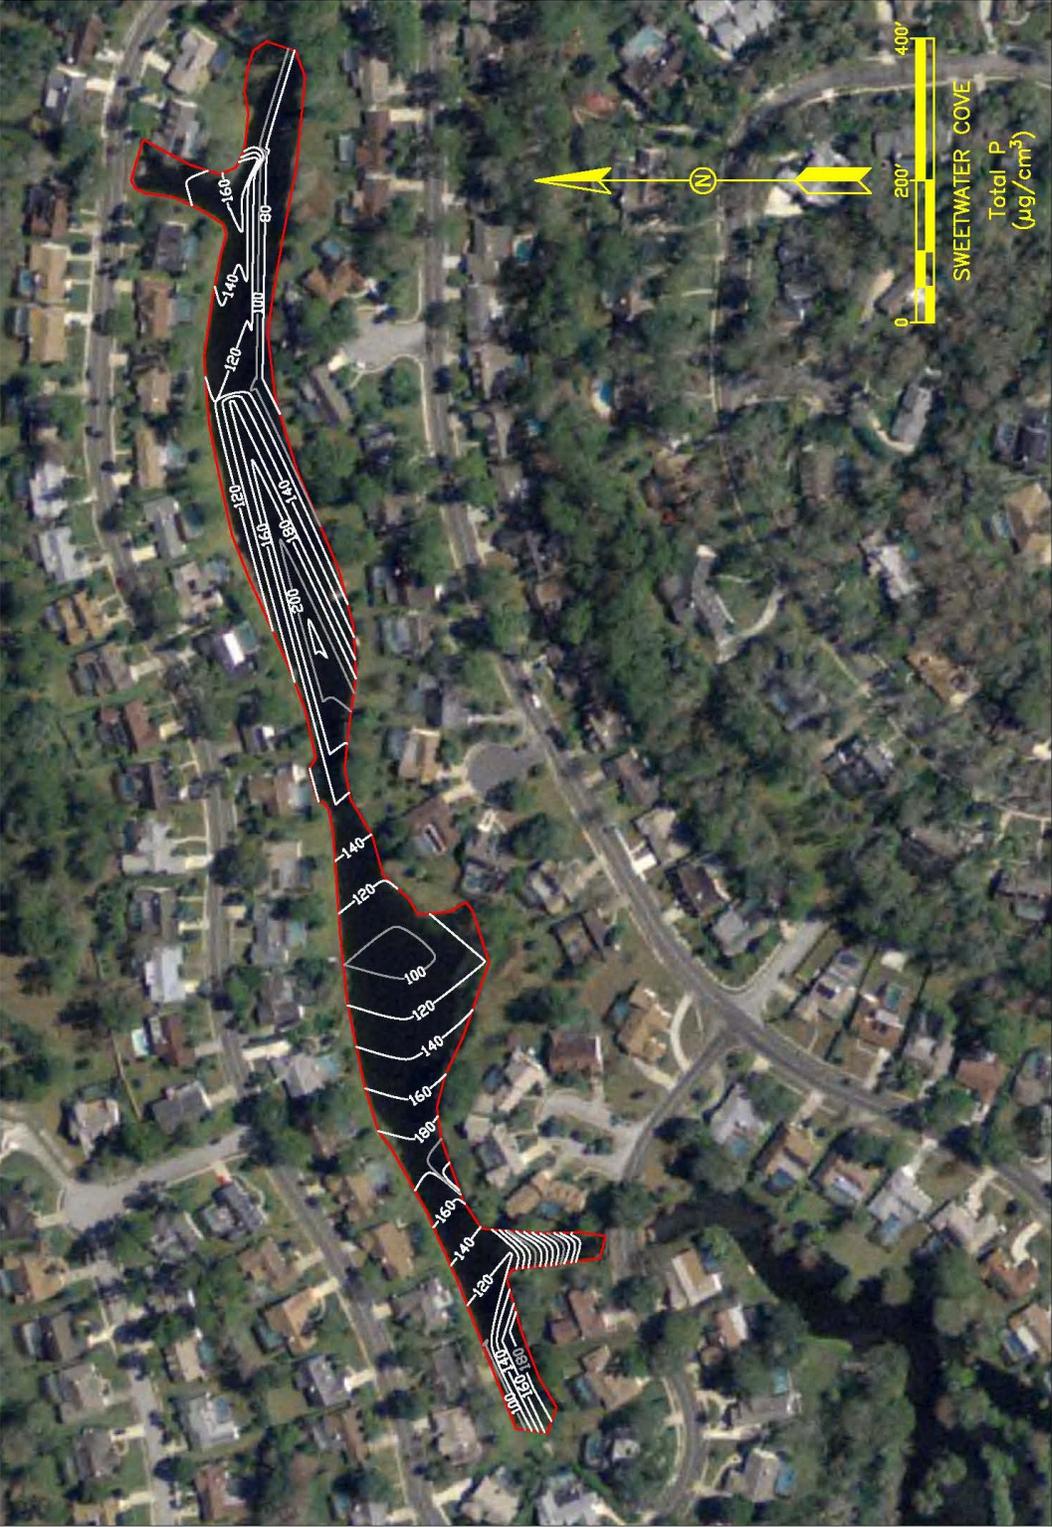
Figure 3-7. Isopleths of Organic Content (% dry wt.) in the Top 10 cm of Sediments in the Lower Lobe of Sweetwater Cove Lake.

Figure 3-8. Isopleths of Wet Density (g/cm^3) in the Top 10 cm of Sediments in the Lower Lobe of Sweetwater Cove Lake.

Figure 3-9. Isopleths of Total Phosphorus ($\mu\text{g}/\text{cm}^3$) in the Top 10 cm of Sediments in the Lower Lobe of Sweetwater Cove Lake.

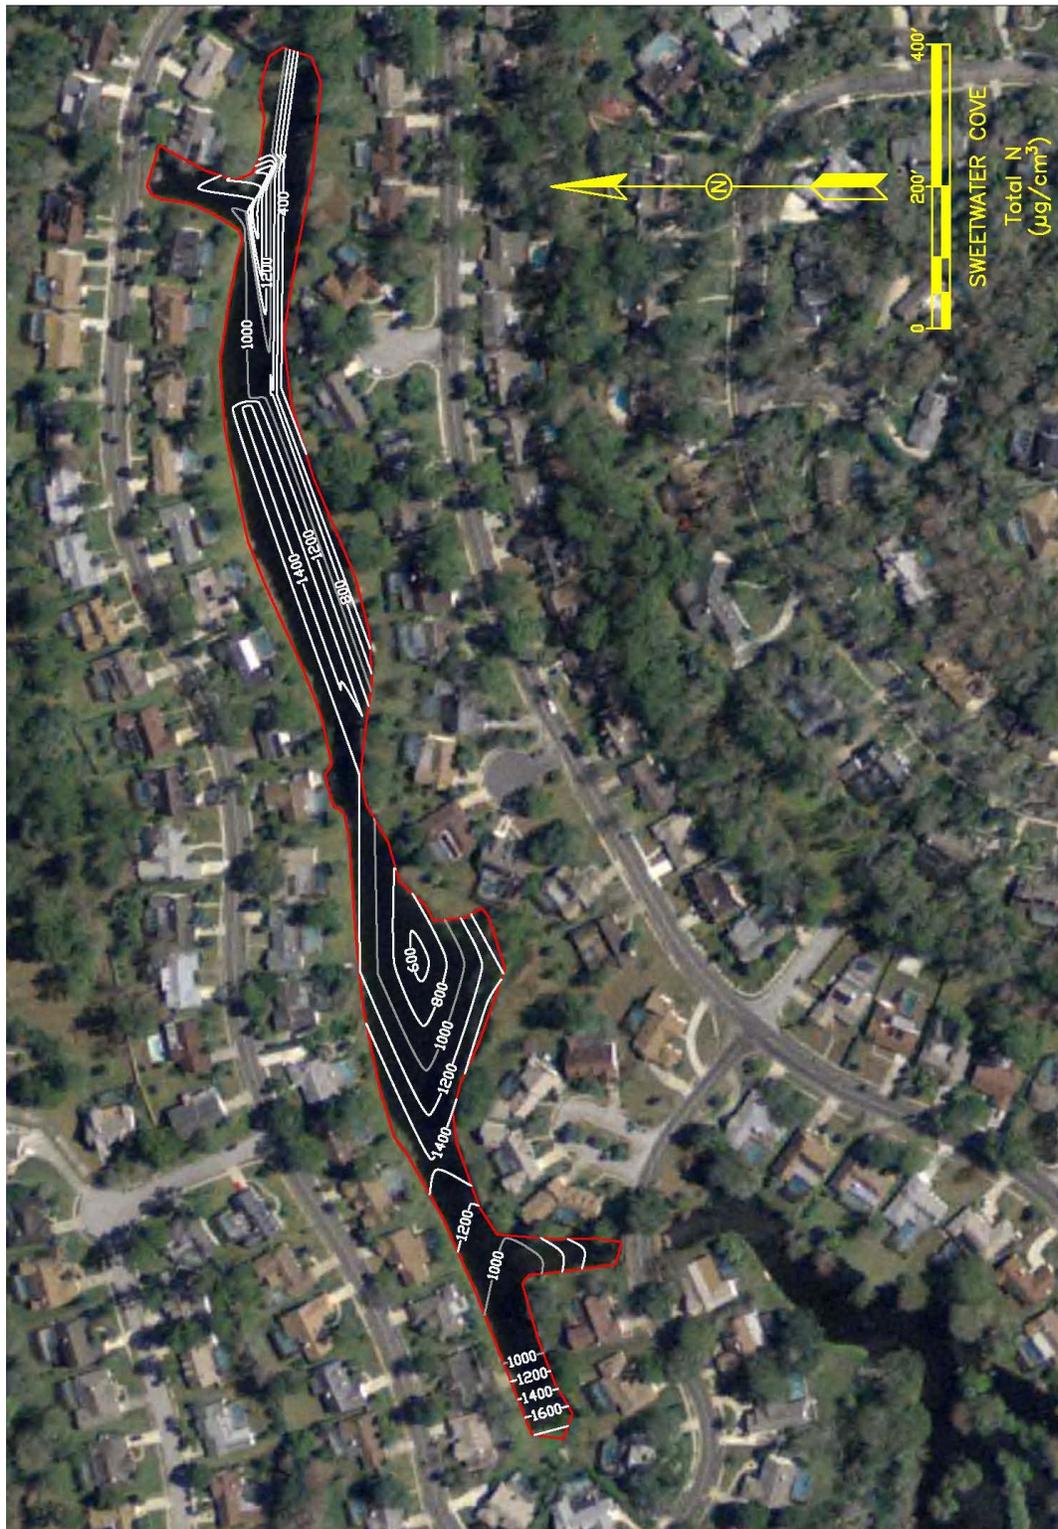
Figure 3-10. Isopleths of Total Nitrogen ($\mu\text{g}/\text{cm}^3$) in the Top 10 cm of Sediments in the Lower Lobe of Sweetwater Cove Lake.

Isopleths of sediment nitrogen concentrations in the lower lobe are illustrated on Figure 3-10. In general, areas of elevated nitrogen concentrations are similar to the patterns exhibited by total phosphorus, with more elevated concentrations present in areas of accumulated organic muck.

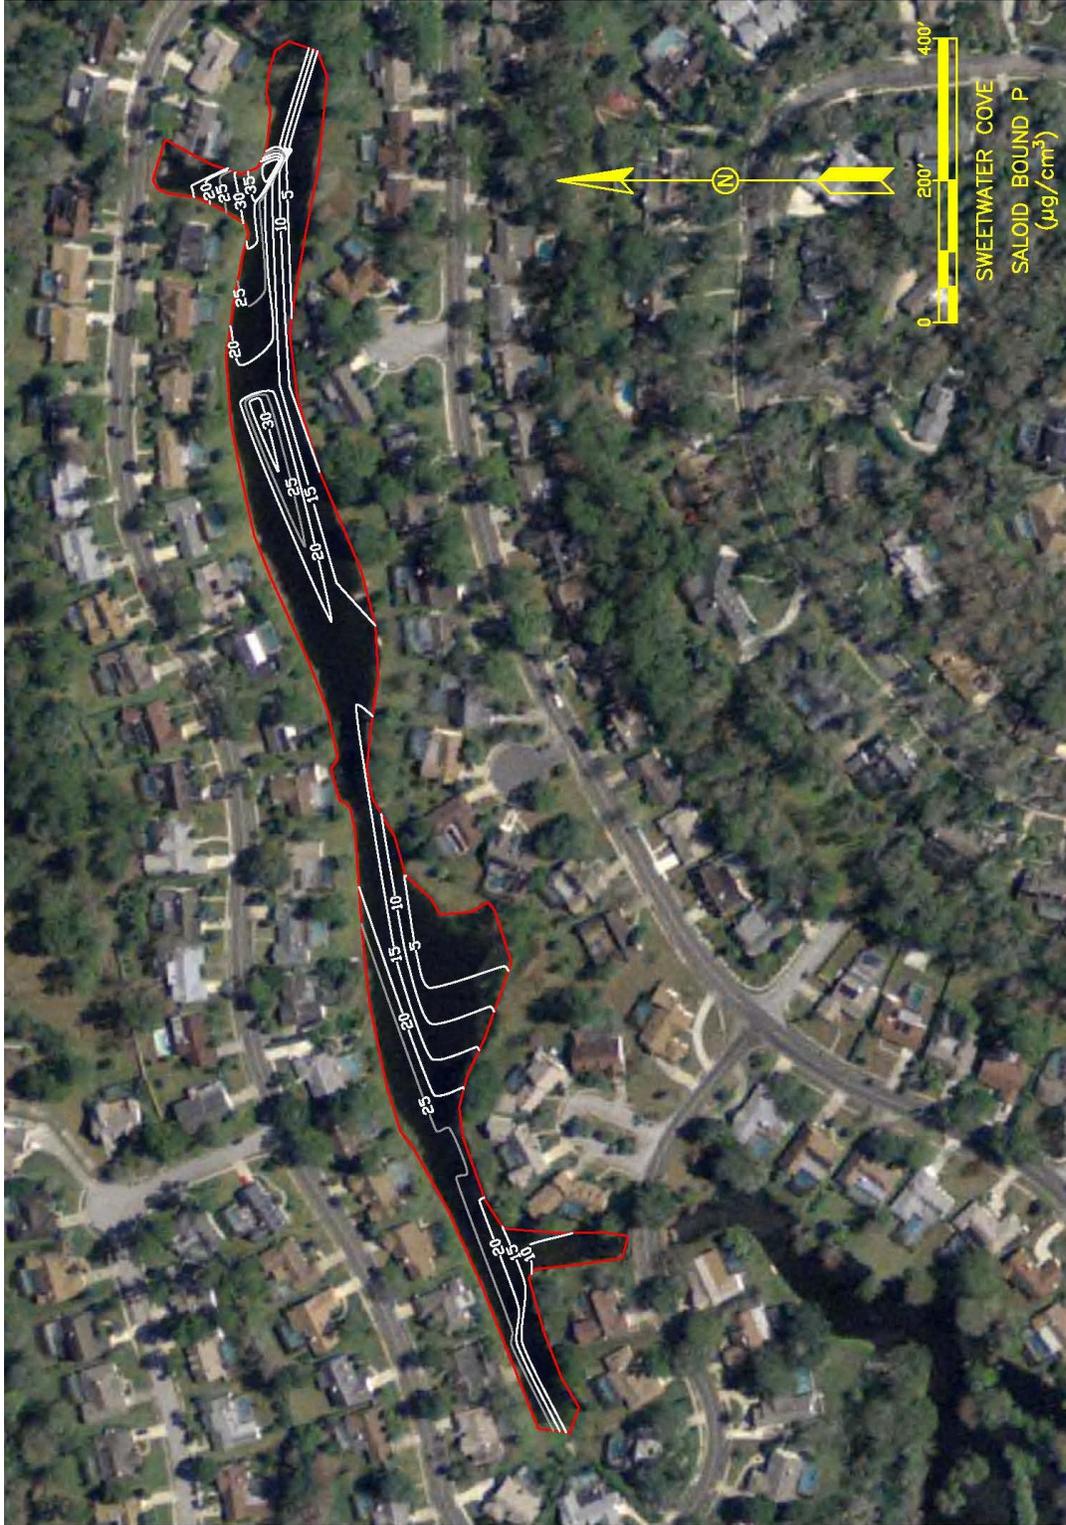
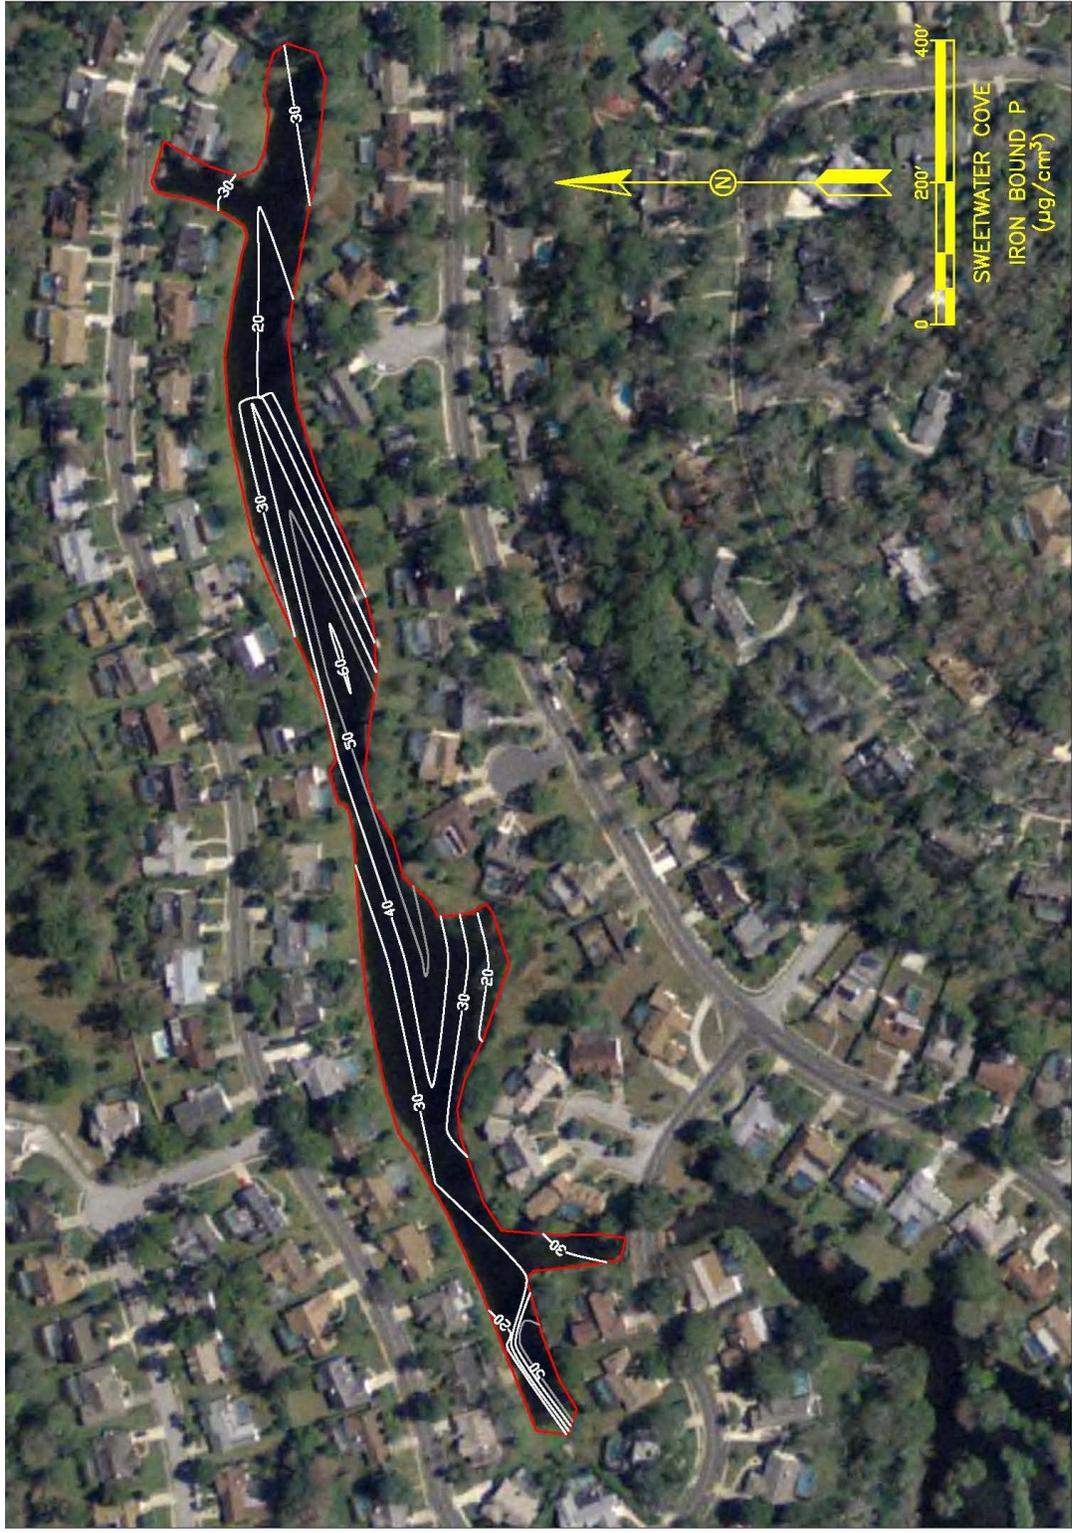
Figure 3-11. Isopleths of Saloid-Bound Phosphorus ($\mu\text{g}/\text{cm}^3$) in the Top 10 cm of Sediments in the Lower Lobe of Sweetwater Cove Lake.

Figure 3-12. Isopleths of Iron-Bound Phosphorus ($\mu\text{g}/\text{cm}^3$) in the Top 10 cm of Sediments in the Lower Lobe of Sweetwater Cove Lake.

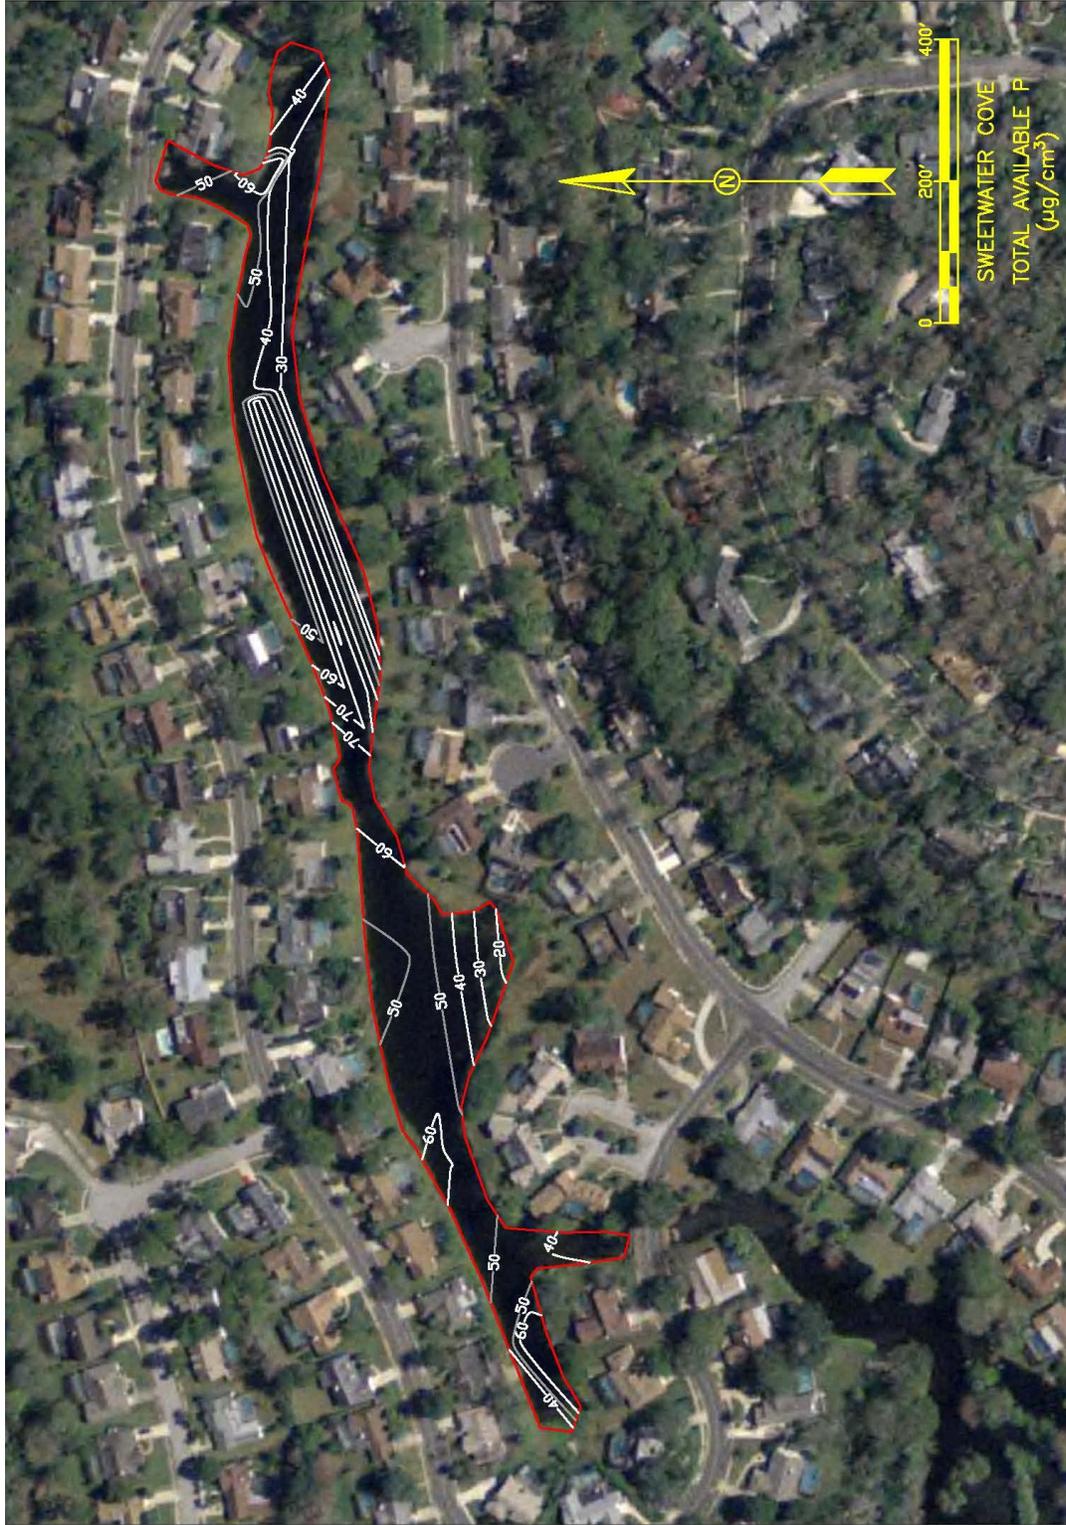
Figure 3-13. Isopleths of Total Available Phosphorus ($\mu\text{g}/\text{cm}^3$) in the Top 10 cm of Sediments in the Lower Lobe of Sweetwater Cove Lake.

Isopleths of total available phosphorus in the top 10 cm of sediments in the lower lobe are illustrated on Figure 3-13. Areas of elevated total available phosphorus are apparent throughout the lower lobe. The isopleths presented on Figure 3-13 can be utilized directly as a guide for future sediment inactivation activities.

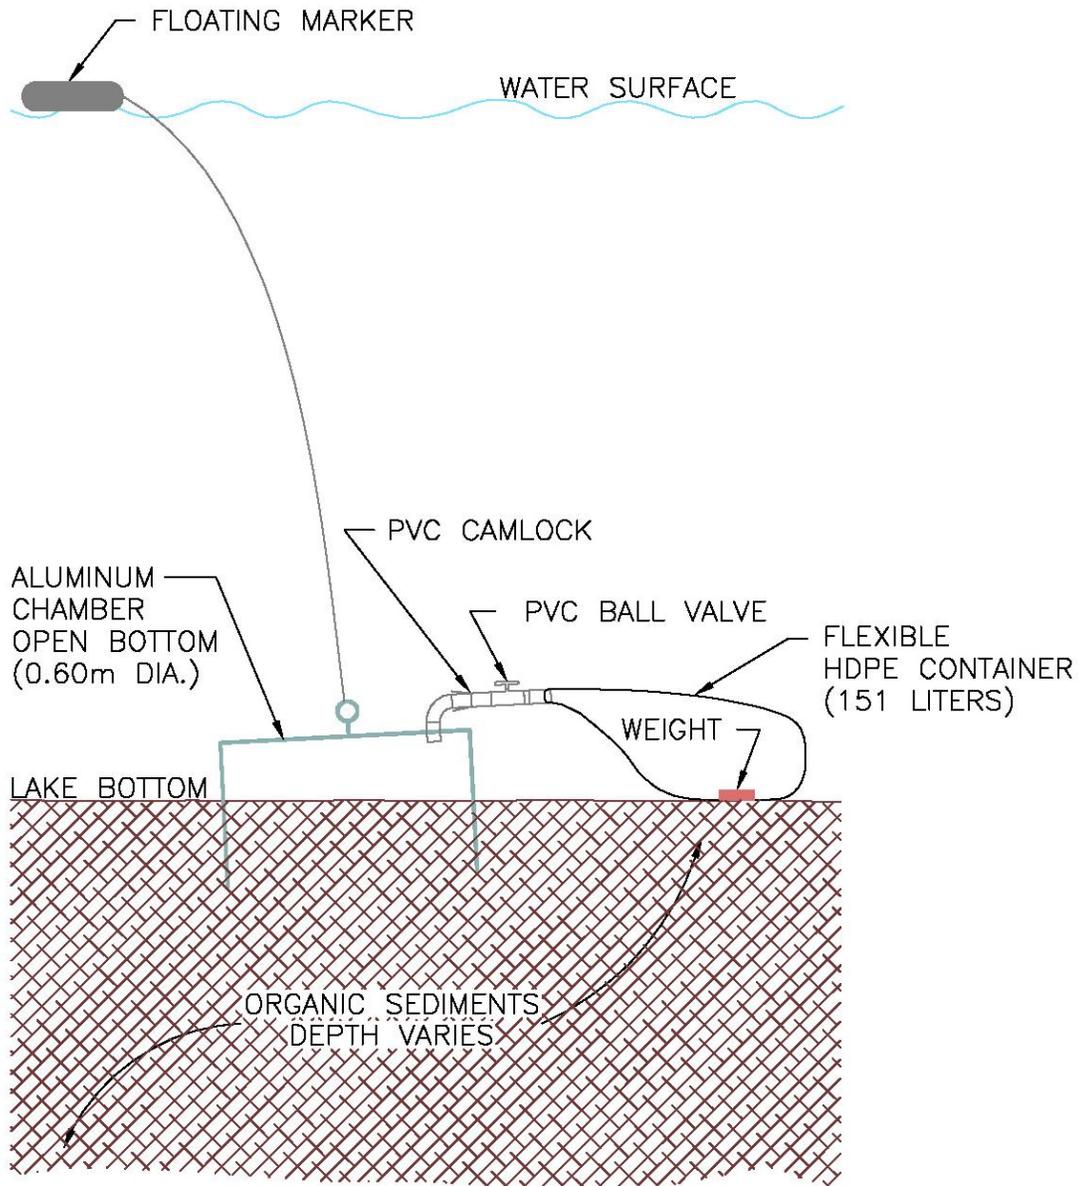
Figure 4-1. Typical Seepage Meter Installation.

A 0.75-inch PVC fitting was threaded into the top of each aluminum container and attached to a female quick-disconnect PVC camlock fitting. A flexible polyethylene bag, with an approximate volume of 40 gallons, was attached to the seepage meters using a quick-disconnect PVC male camlock fitting with a terminal ball valve. Each of the collection bags was constructed of black polyethylene to prevent light penetration into the bag which could potentially stimulate photosynthetic activity within the sample prior to collection and result in an alteration of the chemical characteristics of the sample.

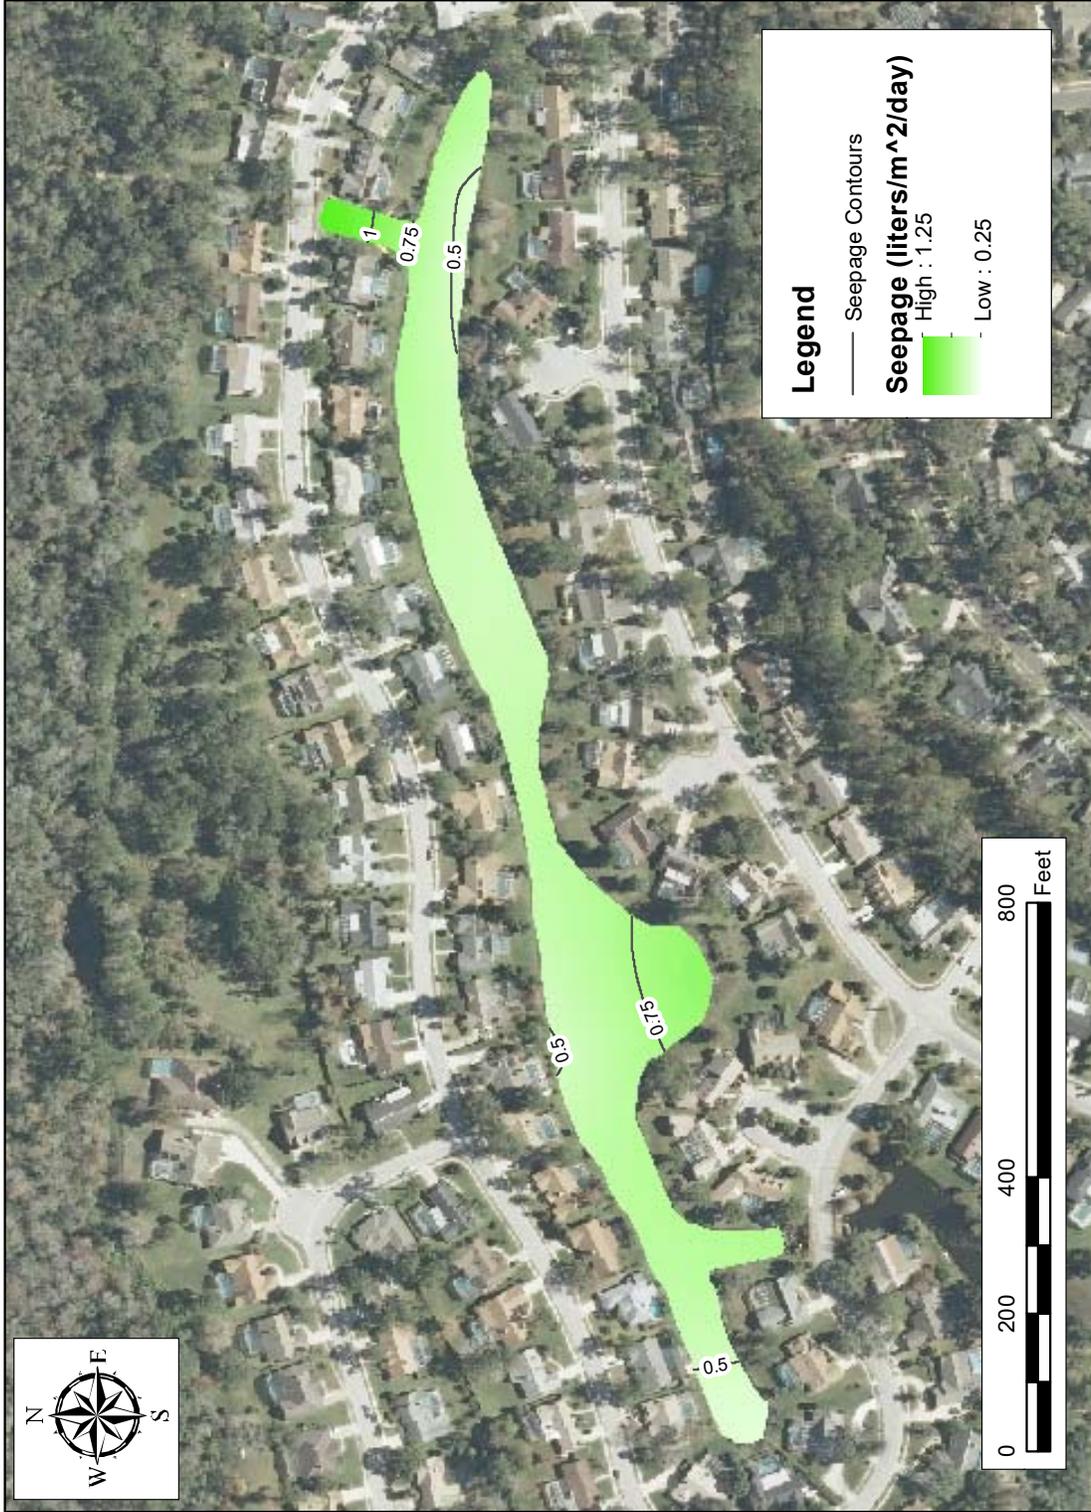
Figure 4-3. Isopleths of Mean Seepage Inflow into the Lower Lobe of Sweetwater Cove Lake from December 2014–June 2015.

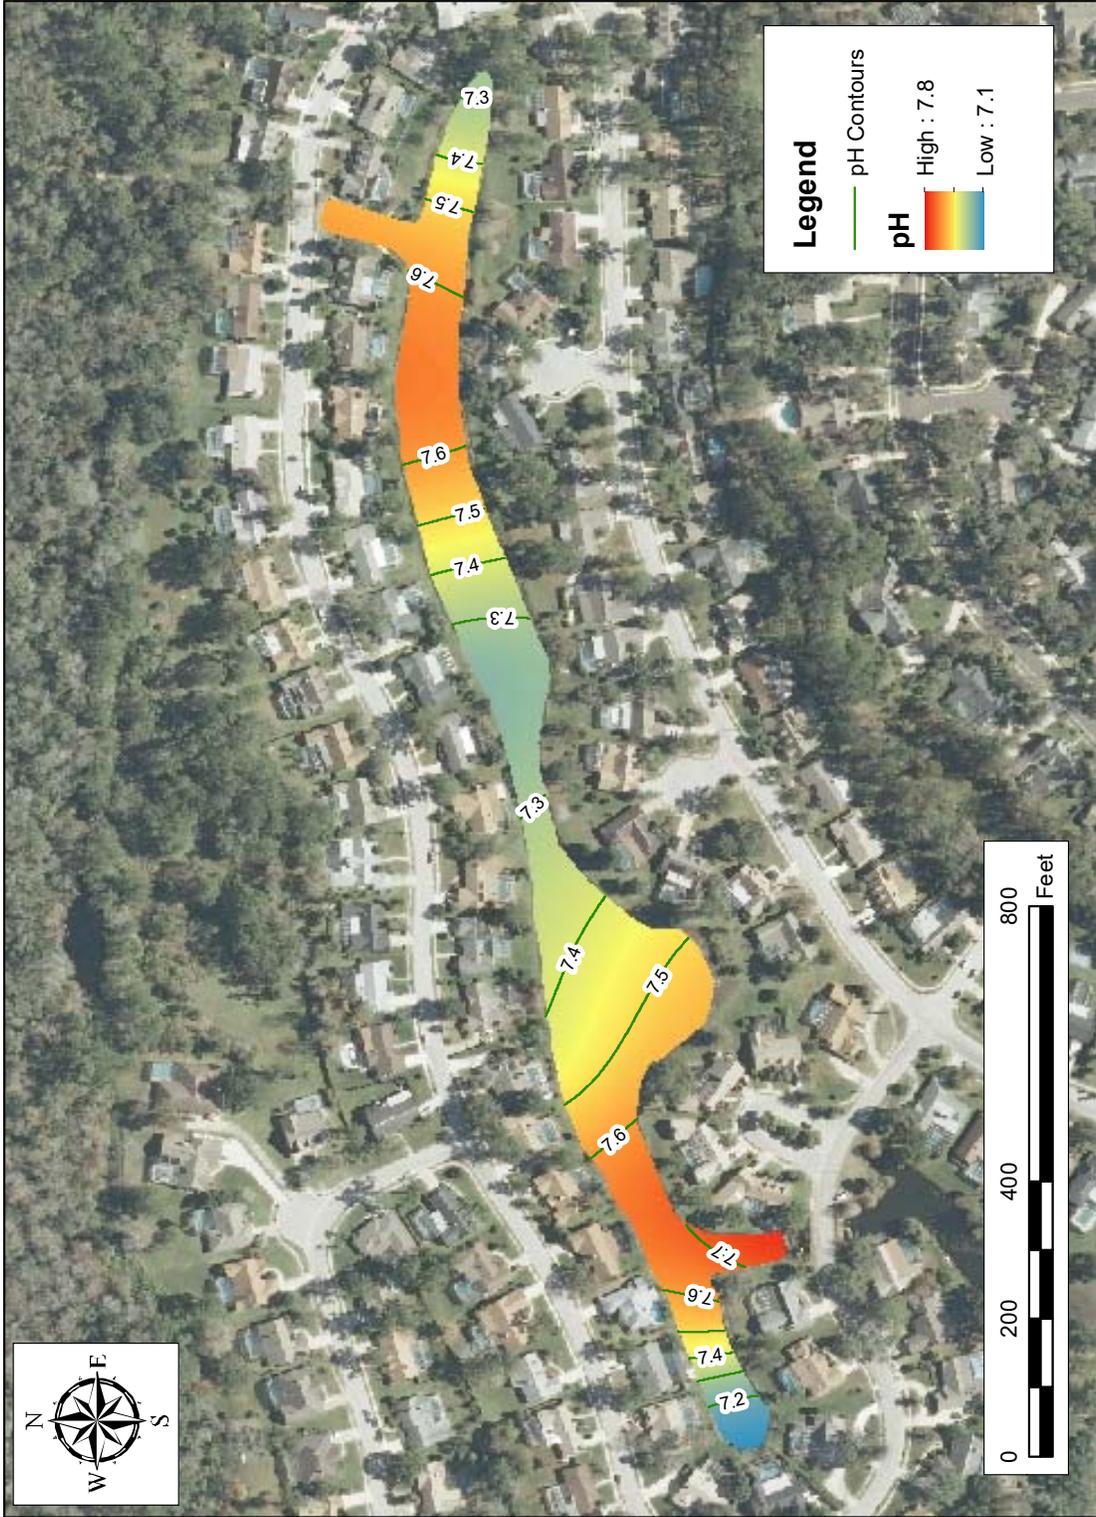
Figure 4-4. Isopleths of Mean pH Values in Groundwater Seepage Entering the Lower Lobe of Sweetwater Cove Lake from December 2014-June 2015.

Isopleths of mean pH values in groundwater seepage entering the lower lobe from December 2014-June 2015 are illustrated on Figure 4-4. In general, the most elevated pH values were observed in central portions of the eastern and western portions of the lake, with the lowest measured pH values observed in central and extreme eastern and western portions of the lake. The measured pH values illustrated on Figure 4-3 are slightly higher than pH values observed by ERD in groundwater seepage entering other lakes in the Central Florida area.

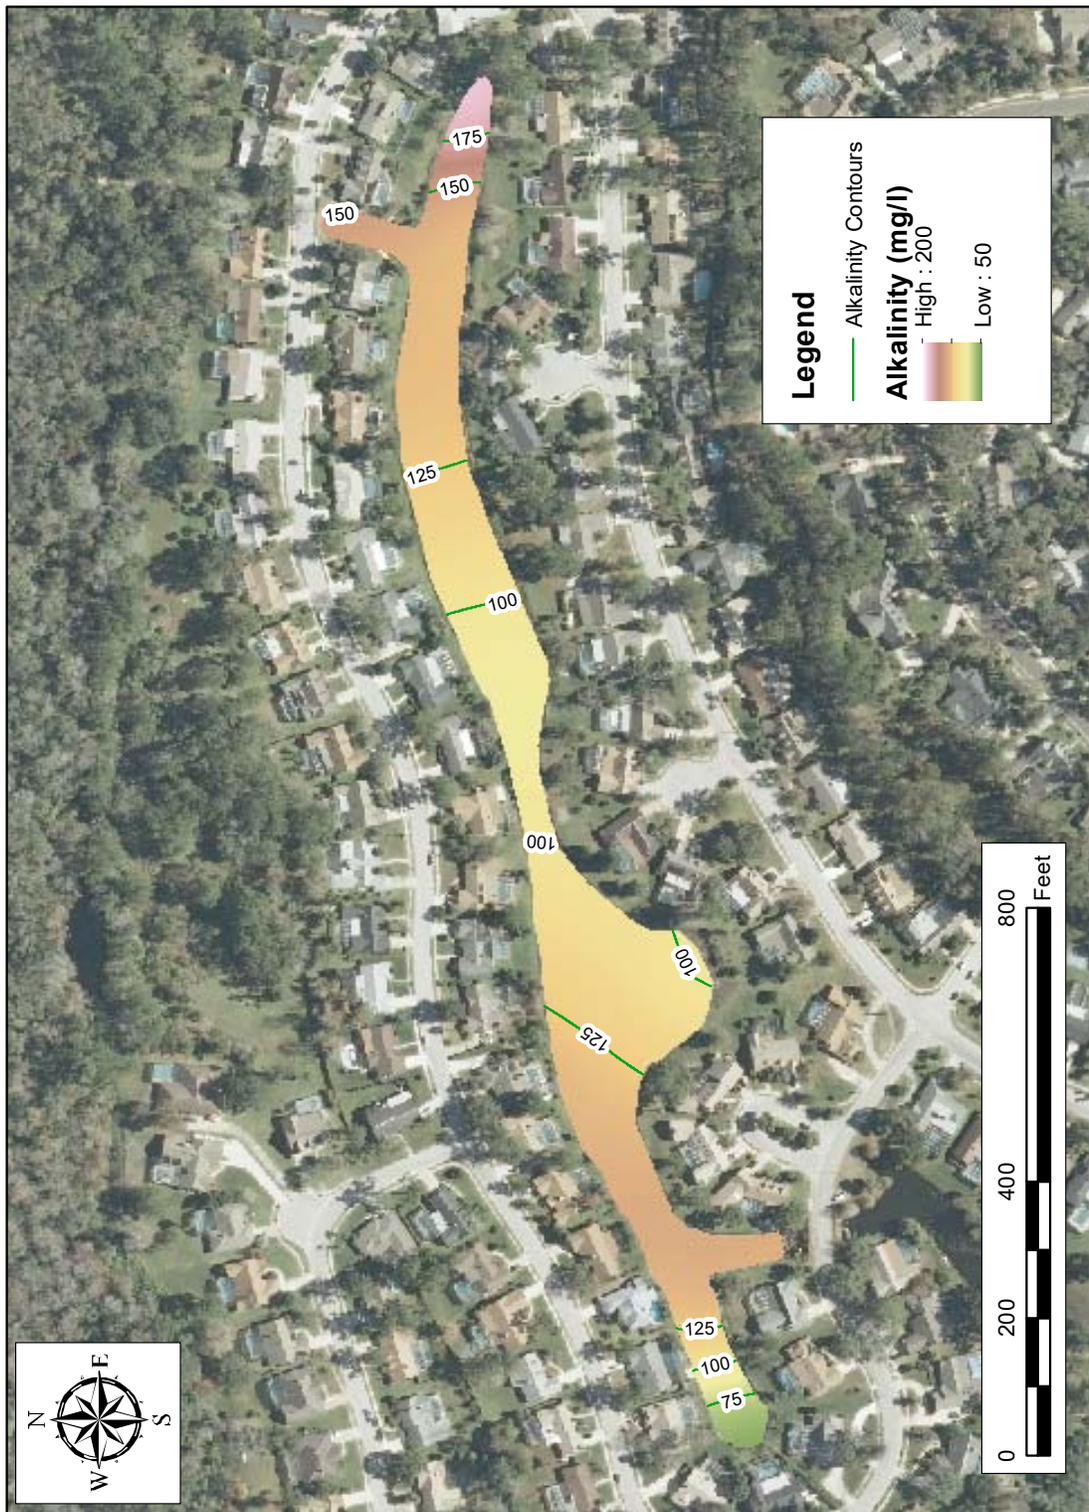
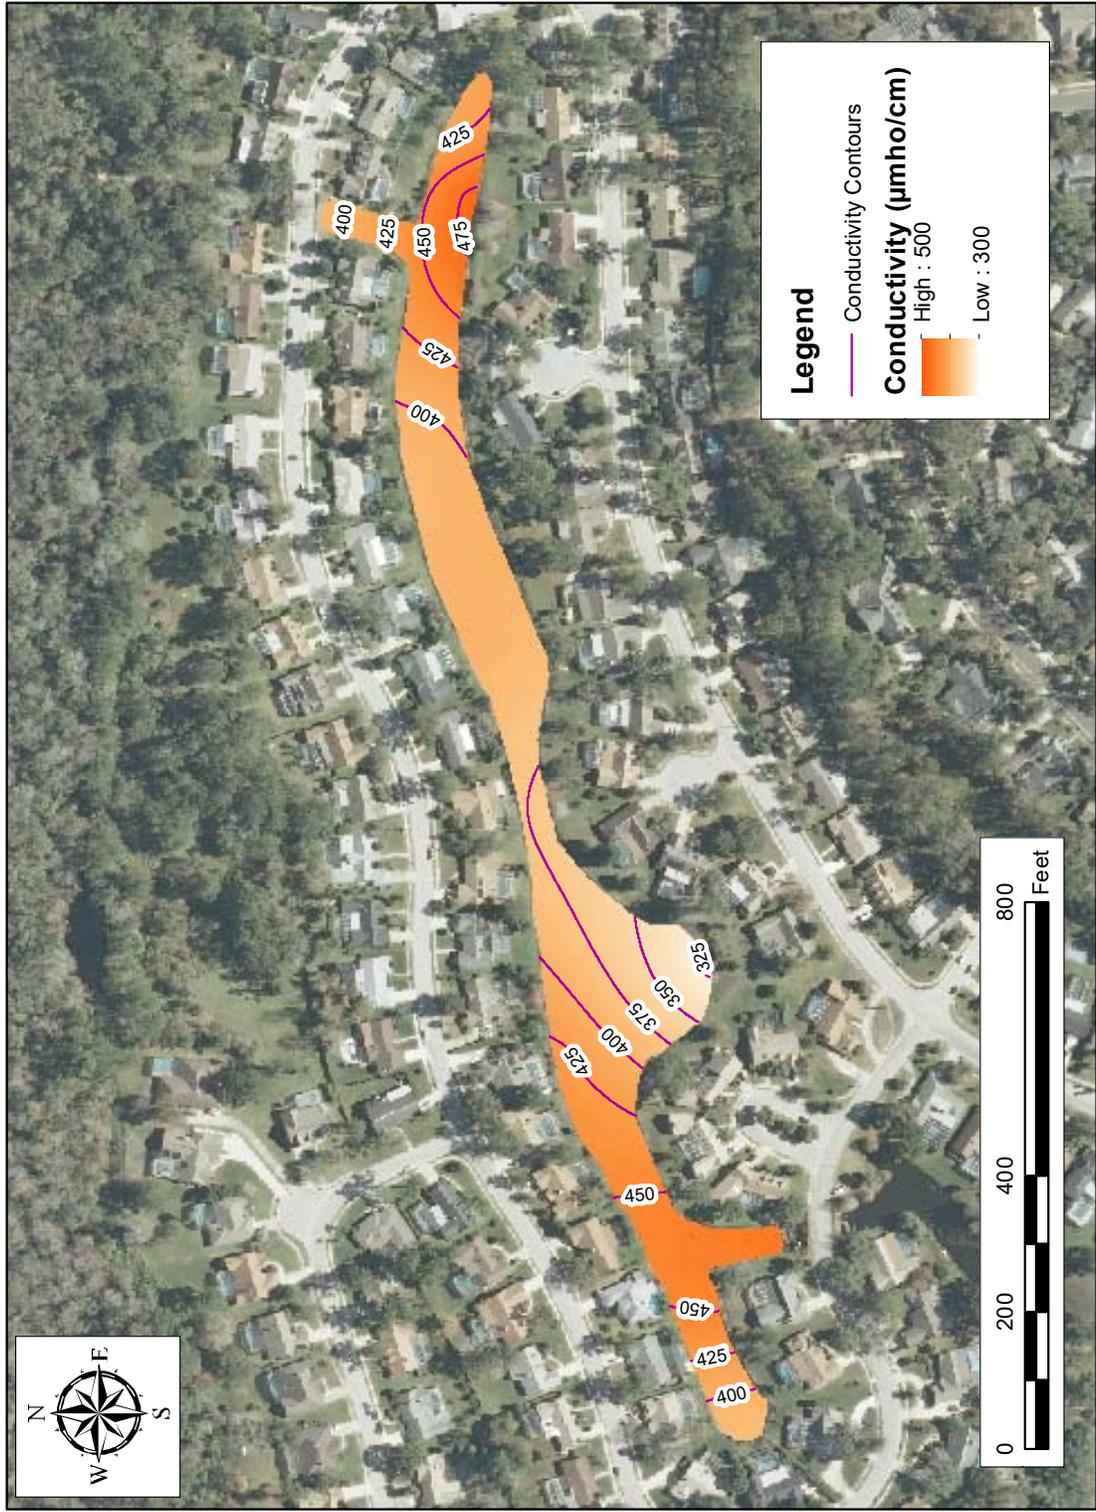
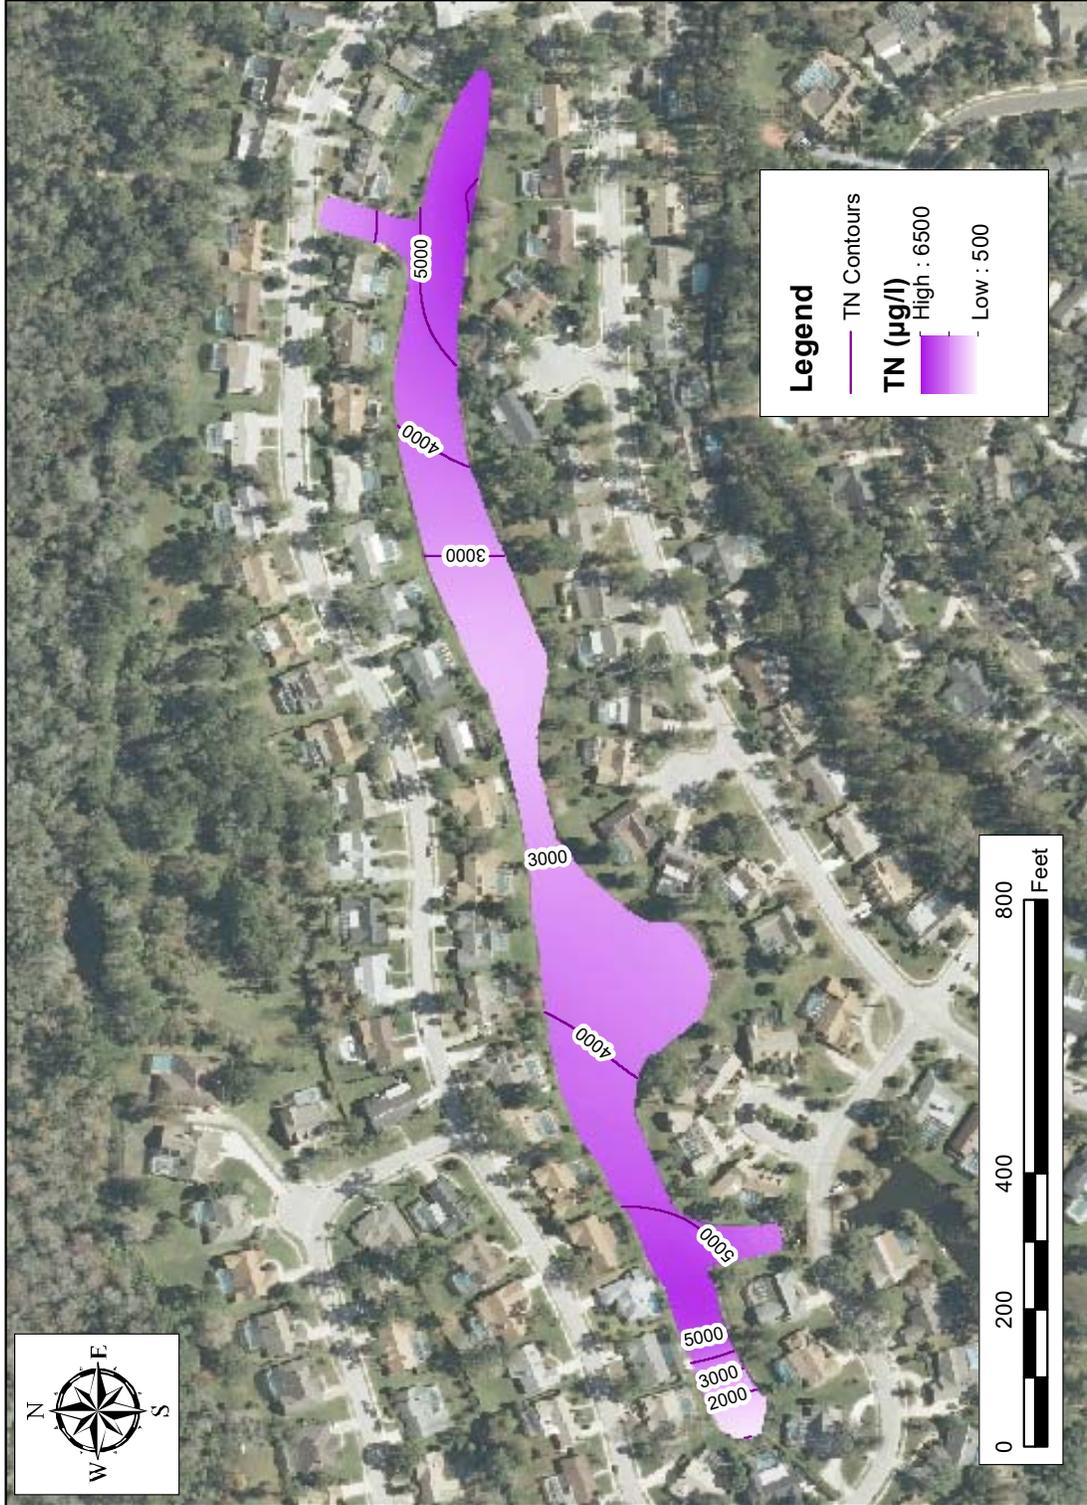
Figure 4-5. Isopleths of Mean Alkalinity Values in Groundwater Seepage Entering the Lower Lobe of Sweetwater Cove Lake from December 2014-June 2015.

Figure 4-6. Isopleths of Mean Conductivity Values in Groundwater Seepage Entering the Lower Lobe of Sweetwater Cove Lake from December 2014-June 2015.

Figure 4-7. Isopleths of Mean Total Nitrogen Values in Groundwater Seepage Entering the Lower Lobe of Sweetwater Cove Lake from December 2014-June 2015.
