SWEETWATER COVE LAKE LYNGBYA NUTRIENT SOURCE EVALUATION

Final Report – December 2015

Seminole County, Florida

**Environmental Research & Design, Inc.
Harvey H. Harper, Ph.D., P.E. – Project Director
3419 Trentwood Blvd., Suite 102
Belle Isle (Orlando), FL 32812-4864
407-855-9465**

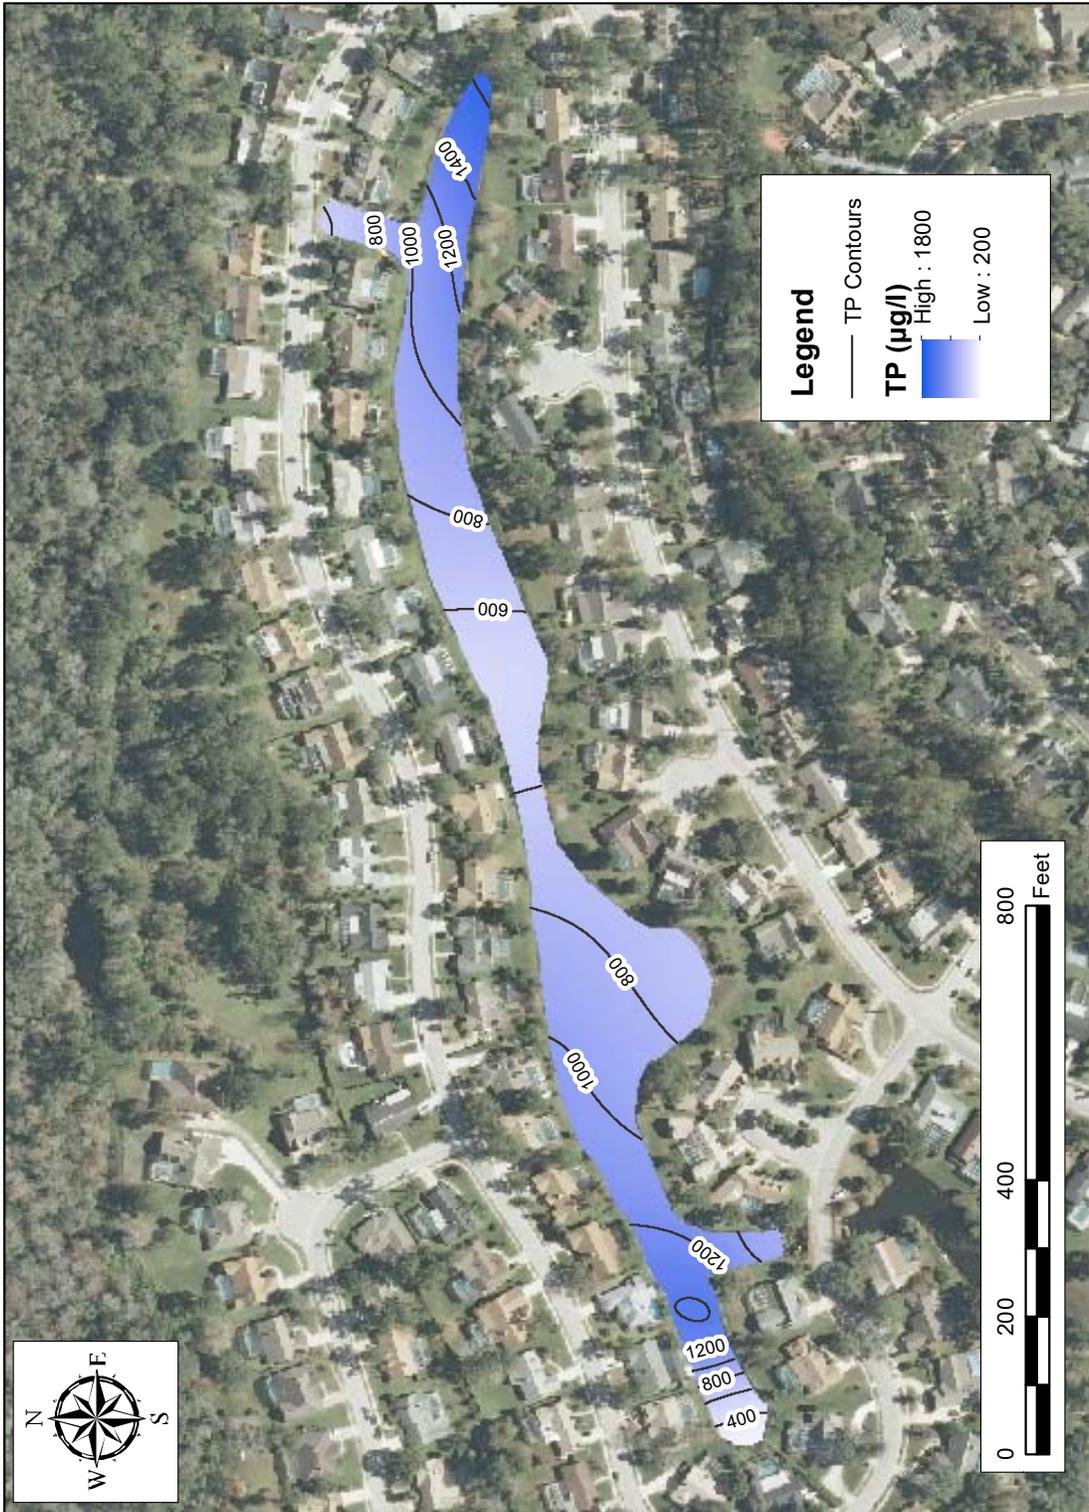
Figure 4-8. Isopleths of Mean Total Phosphorus Values in Groundwater Seepage Entering the Lower Lobe of Sweetwater Cove Lake from December 2014-June 2015.

Isopleths of mean total phosphorus concentrations in groundwater seepage entering the lower lobe from December 2014-June 2015 are illustrated on Figure 4-8. Areas of elevated total phosphorus concentrations are apparent in the eastern and central-western portions of the lake. In general, phosphorus concentrations in groundwater seepage entering the lower lobe appear to be substantially higher in value than concentrations measured by ERD in other Central Florida Lakes. The pattern of elevated total phosphorus concentrations exhibited on Figure 4-8 is similar to the pattern of elevated nitrogen concentrations exhibited on Figure 4-7.

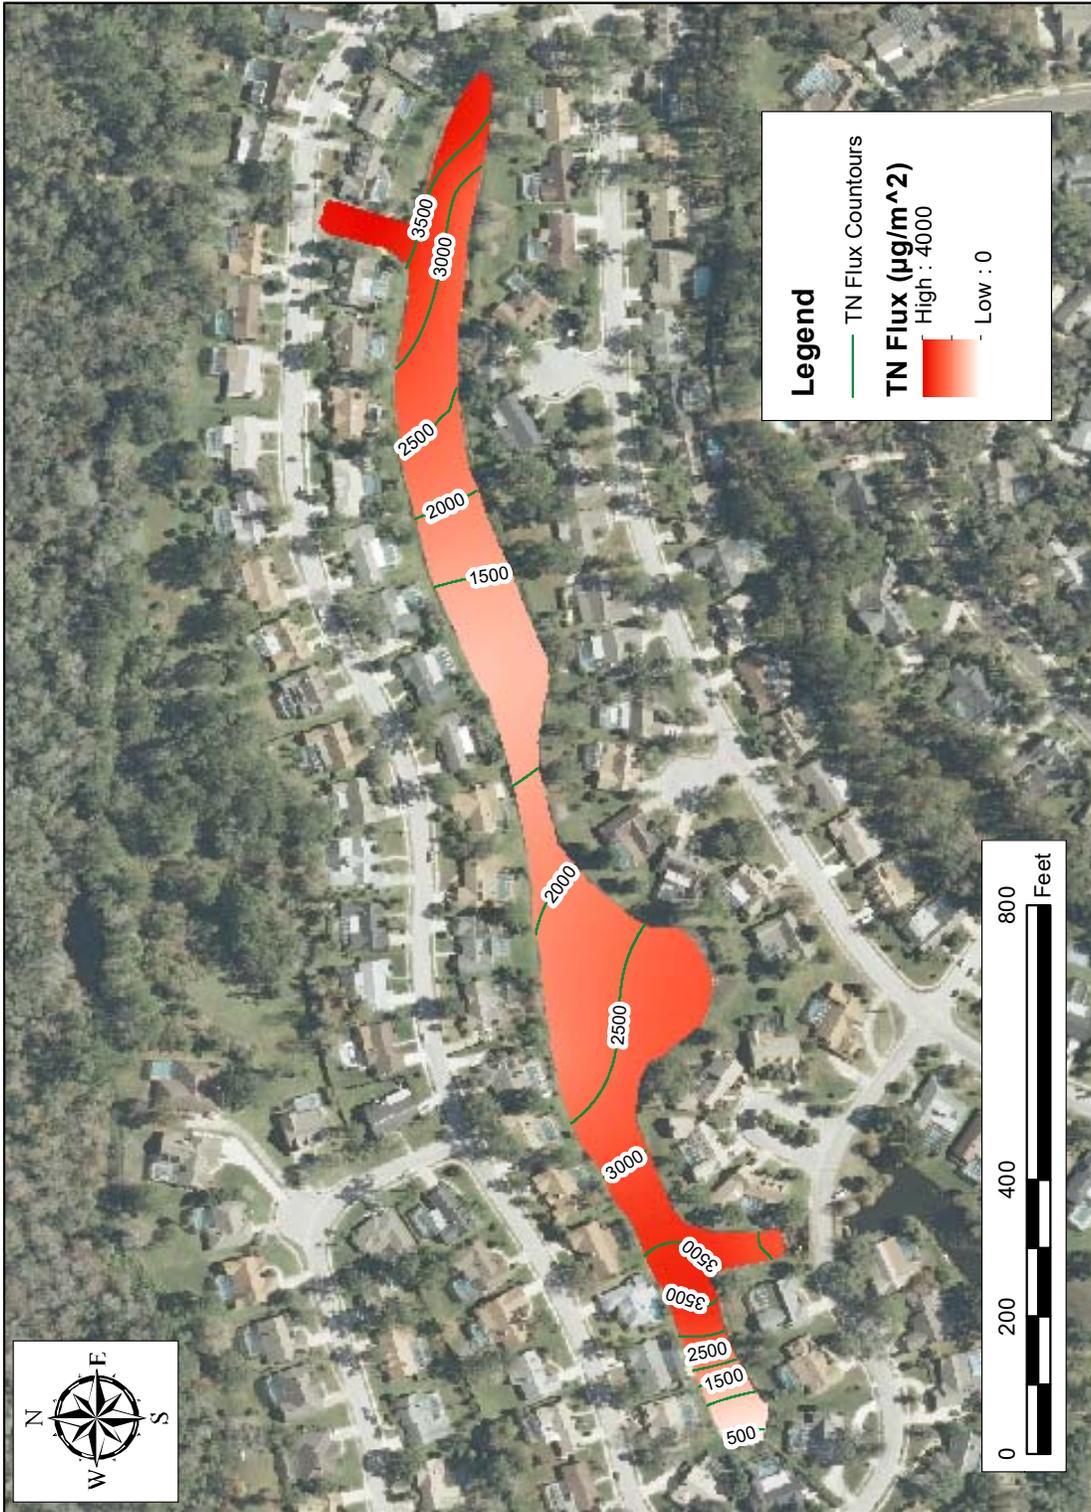
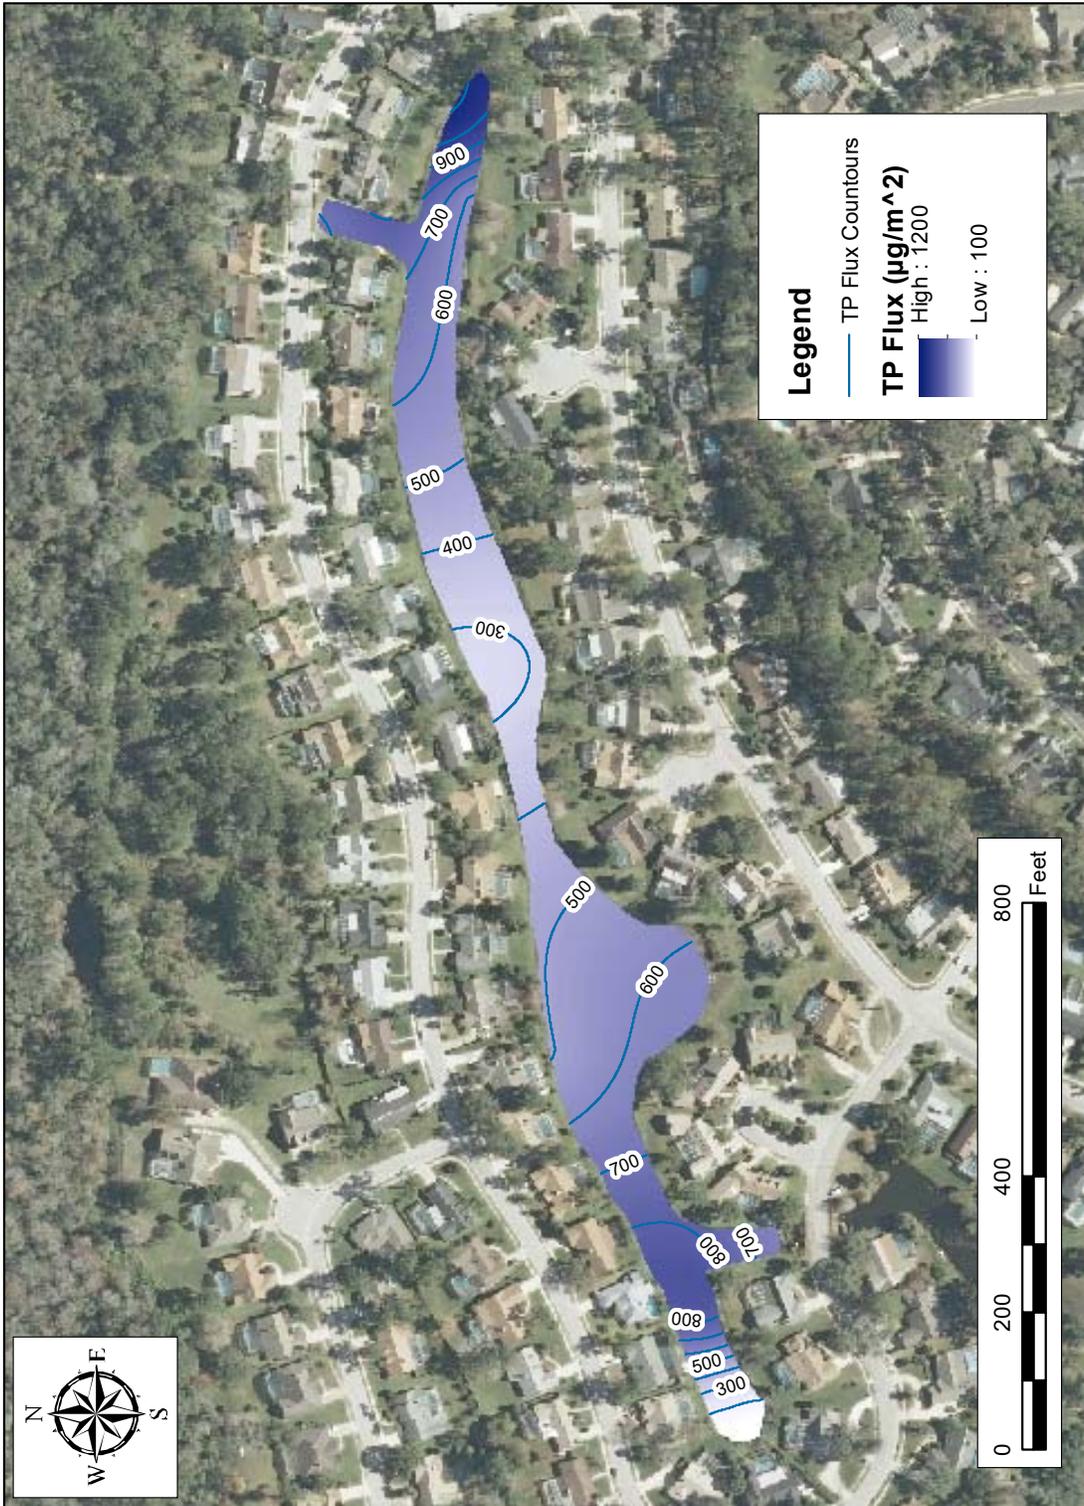
Figure 4-9. Isopleths of Mean Total Nitrogen Influx from Groundwater Seepage to the Lower Lobe of Sweetwater Cove Lake from December 2014-June 2015.

Figure 4-10. Isopleths of Mean Total Phosphorus Influx from Groundwater Seepage to the Lower Lobe of Sweetwater Cove Lake from December 2014-June 2015.

Calculated areal loadings of groundwater seepage are provided at the bottom of Table 4-4 which reflect the mass influx divided by the lake surface area. The mean total nitrogen influx of 3.56 kg/ac-yr entering the lower lobe is lower than the mean seepage influx of total nitrogen measured by ERD in other Central Florida lakes. The mean areal total phosphorus influx from groundwater seepage entering the lower lobe of 0.83 kg/ac-yr is similar to mean areal phosphorus loadings commonly measured by ERD in eutrophic urban lakes. Although the measured concentrations of both total nitrogen and total phosphorus were elevated, the low seepage volumetric inflow rate resulted in loading estimates similar to other urban lakes.

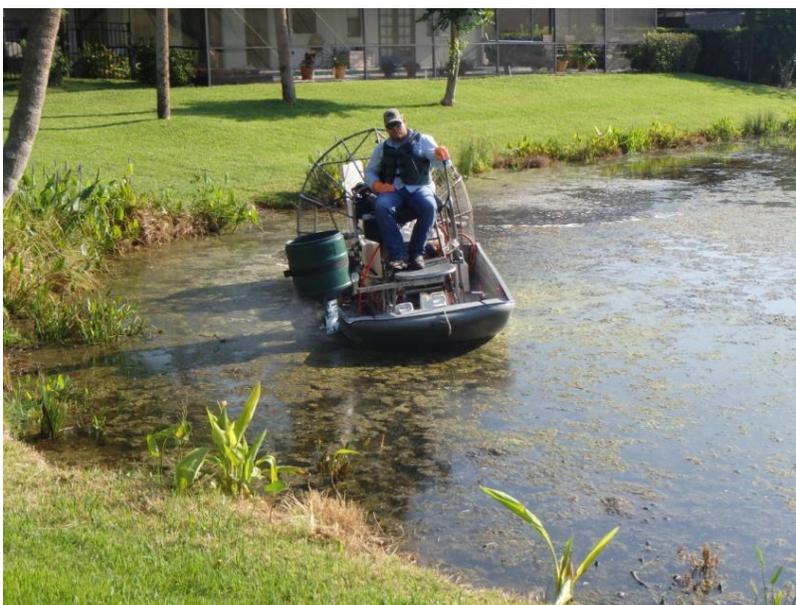
Figure 5-1. Application of PAK 27. (Photo taken on May 19, 2015)

The treatment was initiated on May 19, 2015 by first adding 600 pounds of PAK 27 (totaling 100 pounds/ac-ft) and allowing the product to settle and react overnight. A photograph of application of the PAK 27 is given on Figure 5-1. PAK 27 is a peroxide-based formula which provides algae control through oxidation of organic matter.

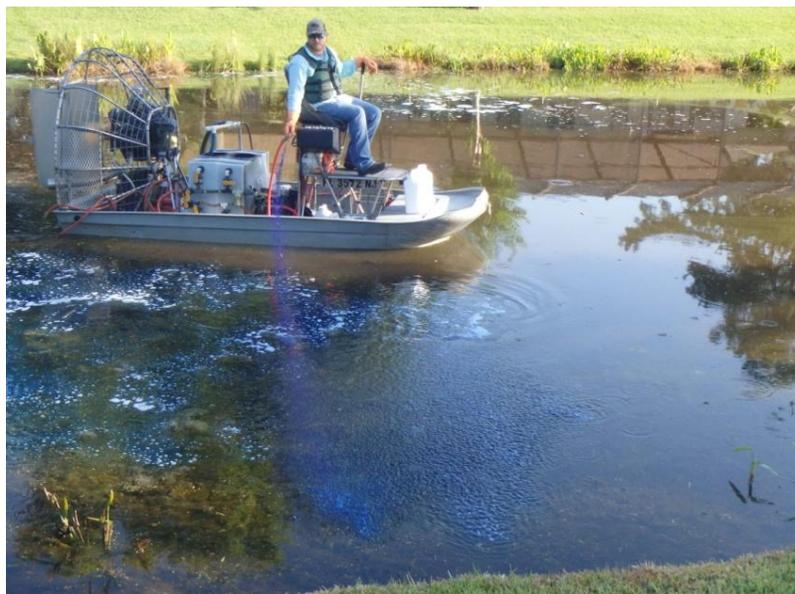
Figure 5-2. Applicator Applying Captain XTR. (Photo taken on May 20, 2015)

On May 20, 2015, 32 gallons of Captain XTR (a chelated copper compound) were applied to the lower lobe at a rate of approximately 0.992 ppm or 5.3 gallons/ac-ft of water. A photograph of the application of Captain XTR is given on Figure 5-2.

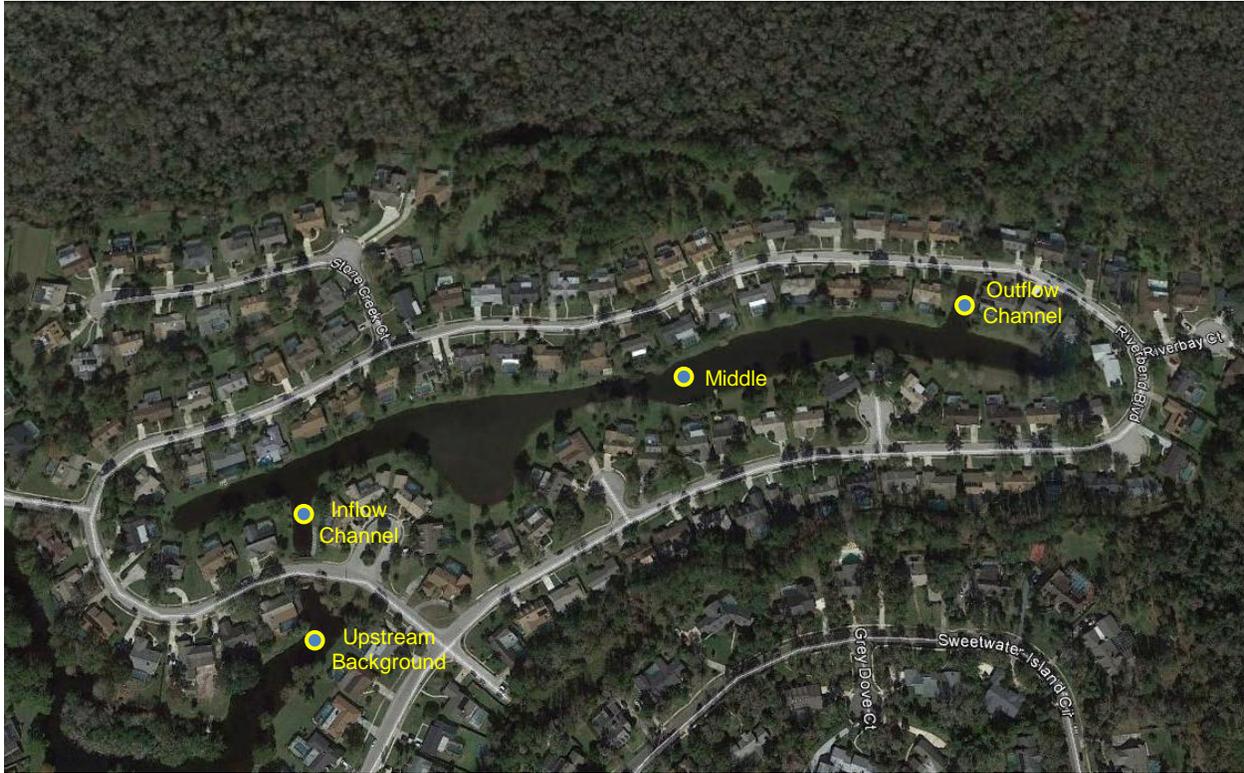
Figure 5-4. Surface Water Monitoring Sites for Post-Treatment Monitoring.

Vertical field profiles of temperature, pH, conductivity, TDS, dissolved oxygen concentration, dissolved oxygen saturation, and ORP were conducted at water depths of 0.25 m and 0.5 m, continuing at 0.5 m intervals to the lake bottom at each site. A measurement of Secchi disk depth was also conducted at each of the four sites. Surface water samples were collected at each site approximately mid-way within the water column and returned to the ERD Laboratory for evaluation of general parameters, nutrients, microbiological parameters, and total copper. The field monitoring and laboratory analyses were conducted using the methods and protocol used by ERD for routine water quality monitoring in the lower lobe outlined in Section 2.1. In addition to the parameters and analytical methods summarized in Table 2-1, additional parameters of BOD, fecal coliform, E. Coli, and total copper were added for the samples collected on May 22, 2015. A summary of analytical methods and detection limits for these additional parameters, which were also conducted in the ERD Laboratory, is given in Table 5-1.

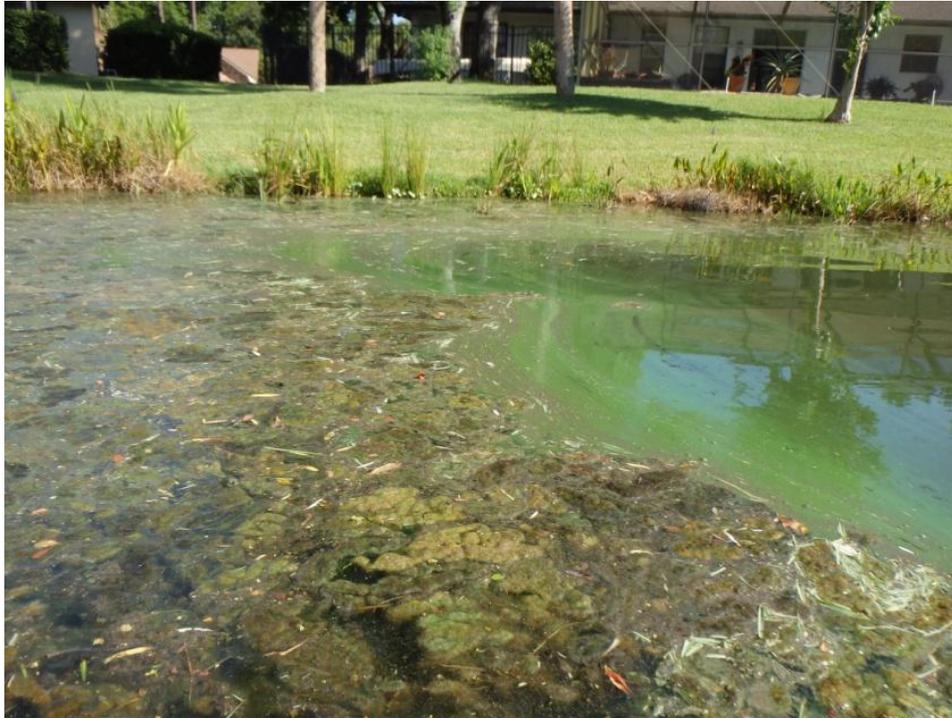
Figure 5-5. Conditions in the Lower Lobe on May 29, 2015

A photograph of observed conditions in the lower lobe on May 29, 2015, approximately 9 days after treatment (DAT) is given on Figure 5-5. Prolific growth of Lyngbya was observed throughout many portions of the lower lobe. Although some of the Lyngbya appeared to be in distress and may have eventually died, large portions of the Lyngbya mat still exhibit a healthy green coloration.

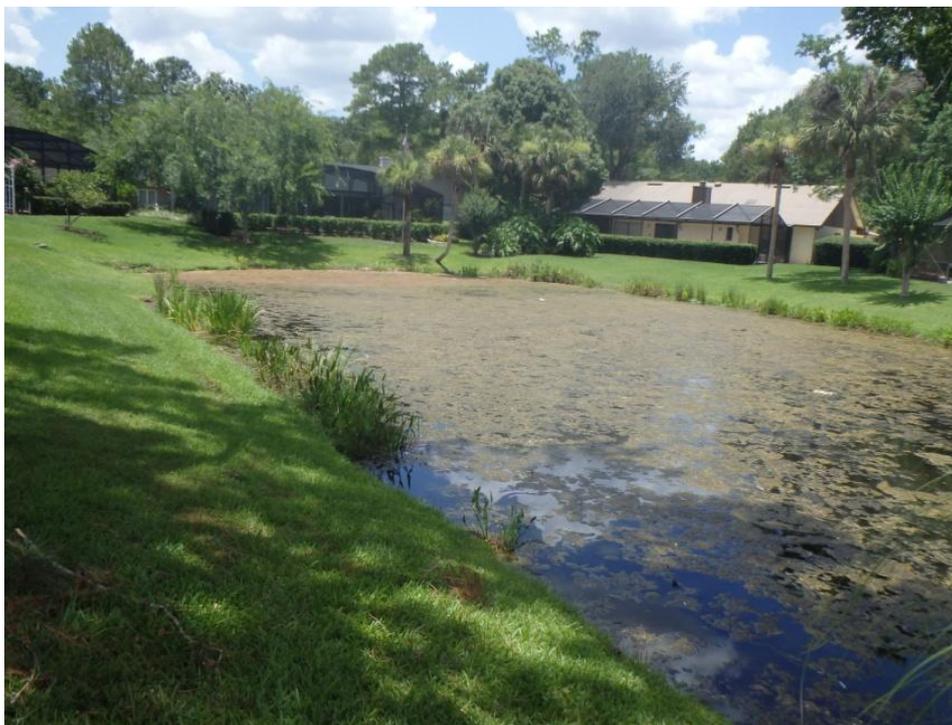
Figure 5-6. Conditions in the Lower Lobe on June 2015.

A photograph of the conditions in the lower lobe on June 15, 2015, approximately 25 DAT, is given on Figure 5-6. Lyngbya growth is still evident throughout large portions of the lower lobe and appears to have expanded in coverage since the photograph taken on May 29, 2015. Although portions of the Lyngbya growth appear to be in distress, the majority of the observed growth appears to be in a healthy condition.

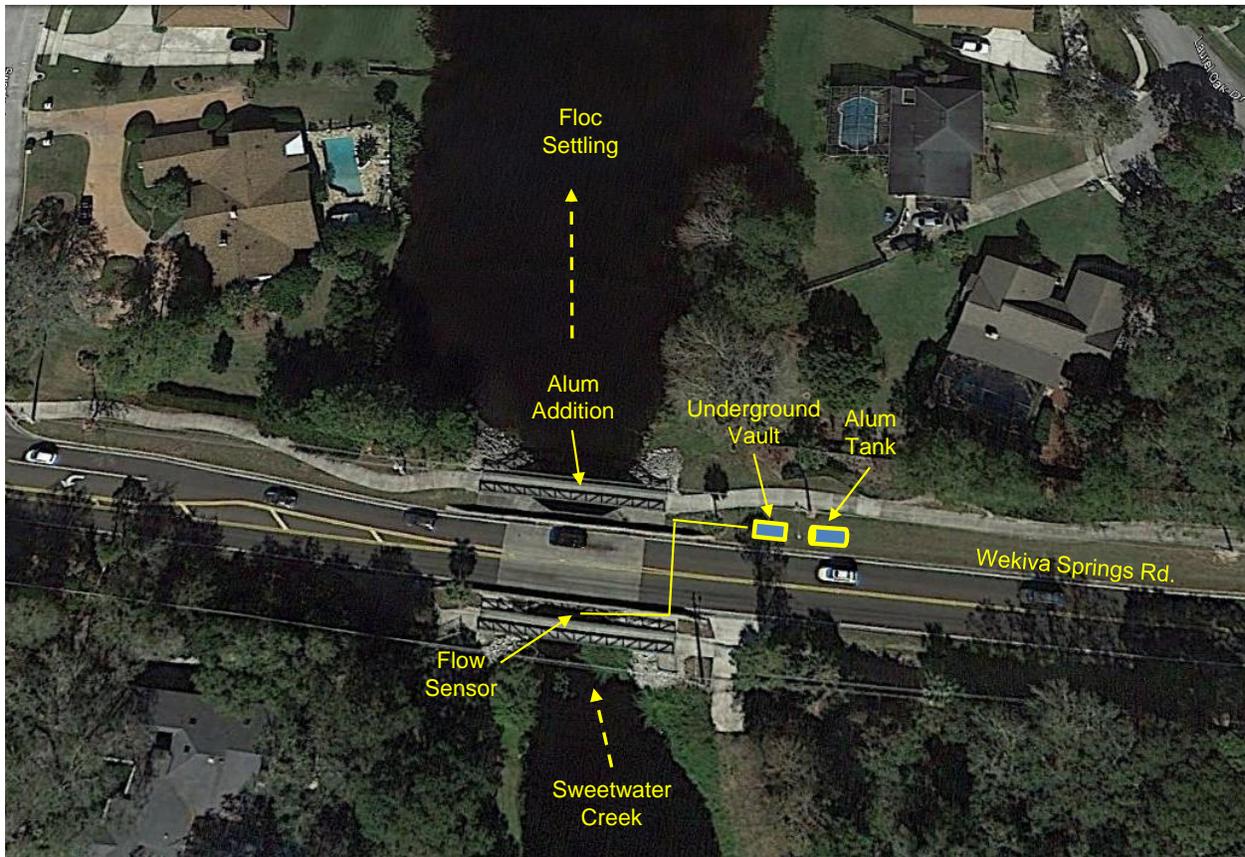
Figure 6-1. Conceptual Schematic of an Alum Addition System for Sweetwater Creek.

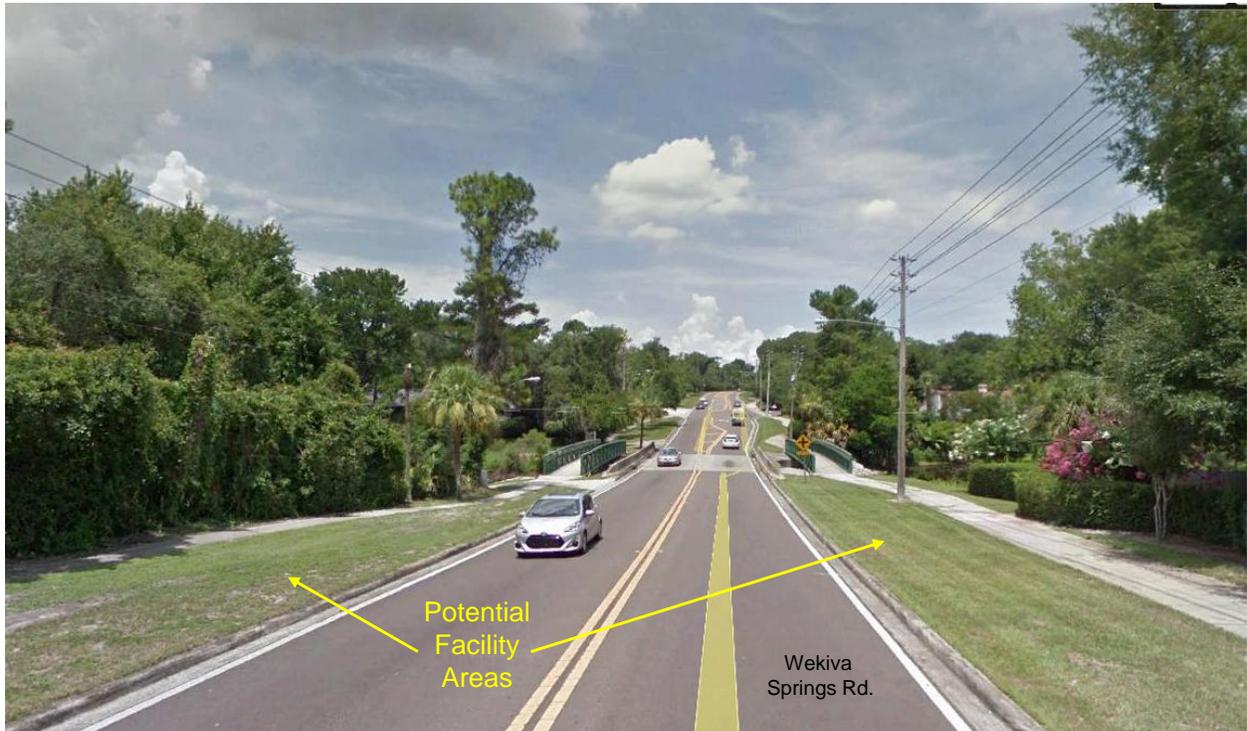
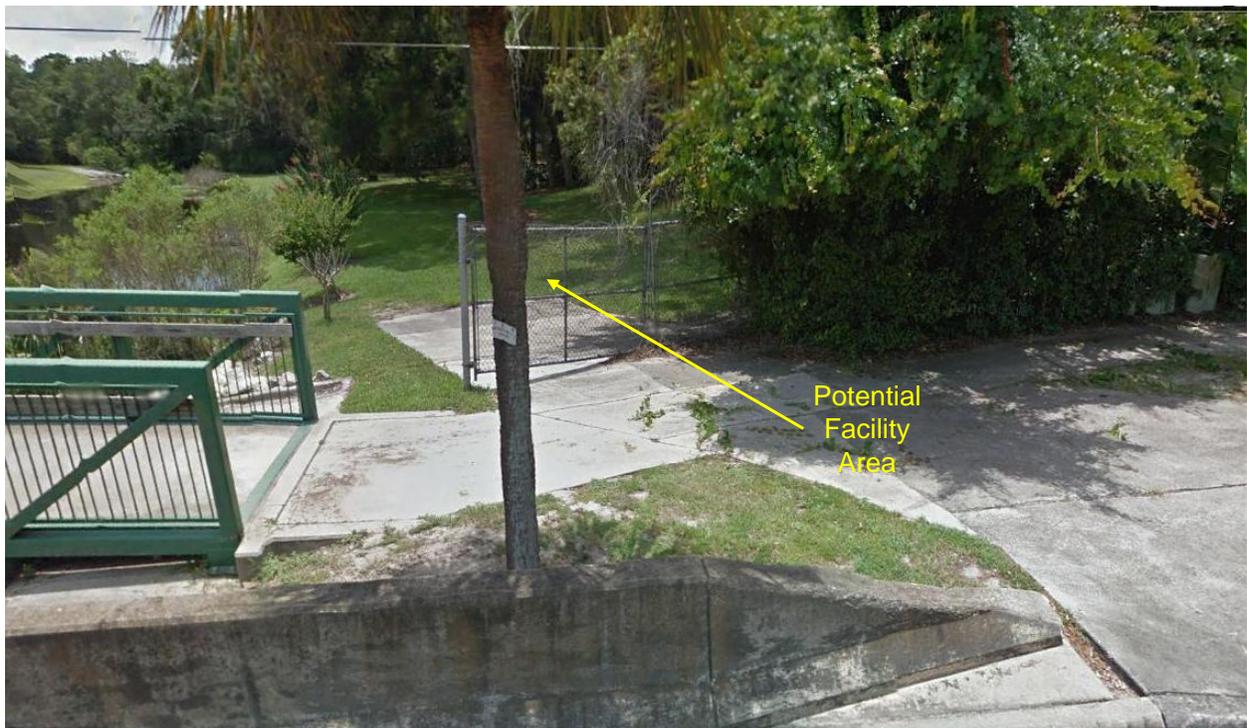
Figure 6-2. Potential Locations for Underground Alum Treatment System Components.

Figure 6-3. Potential Locations for Above-ground Alum Treatment System Components.

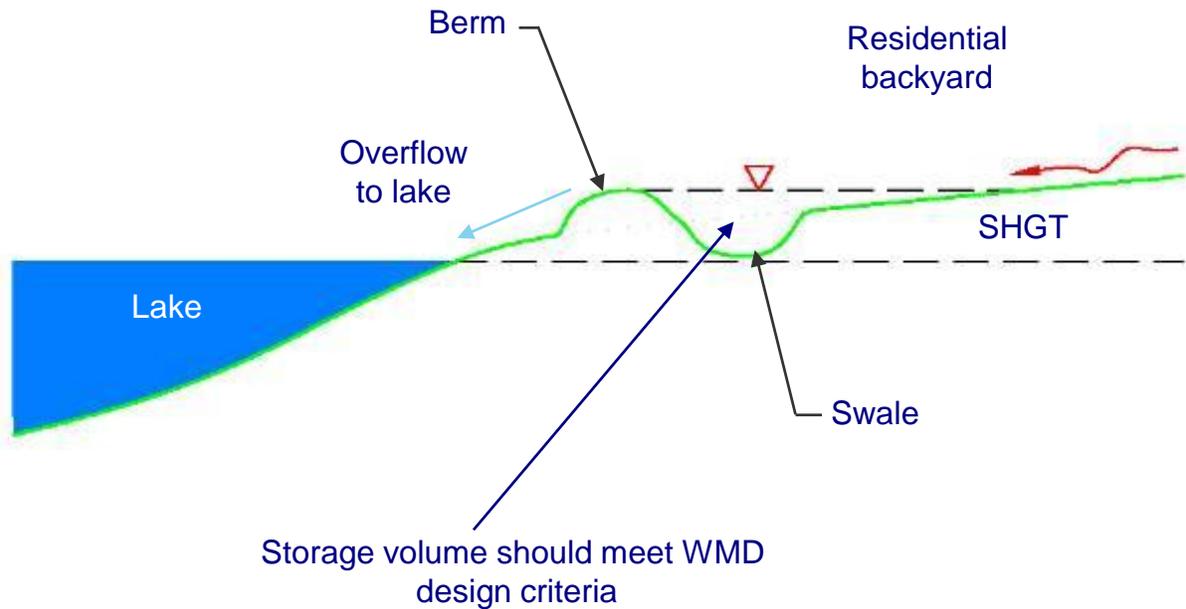
Figure 6-4. Schematic of Recommended Rear Yard Swale and Berm Design.

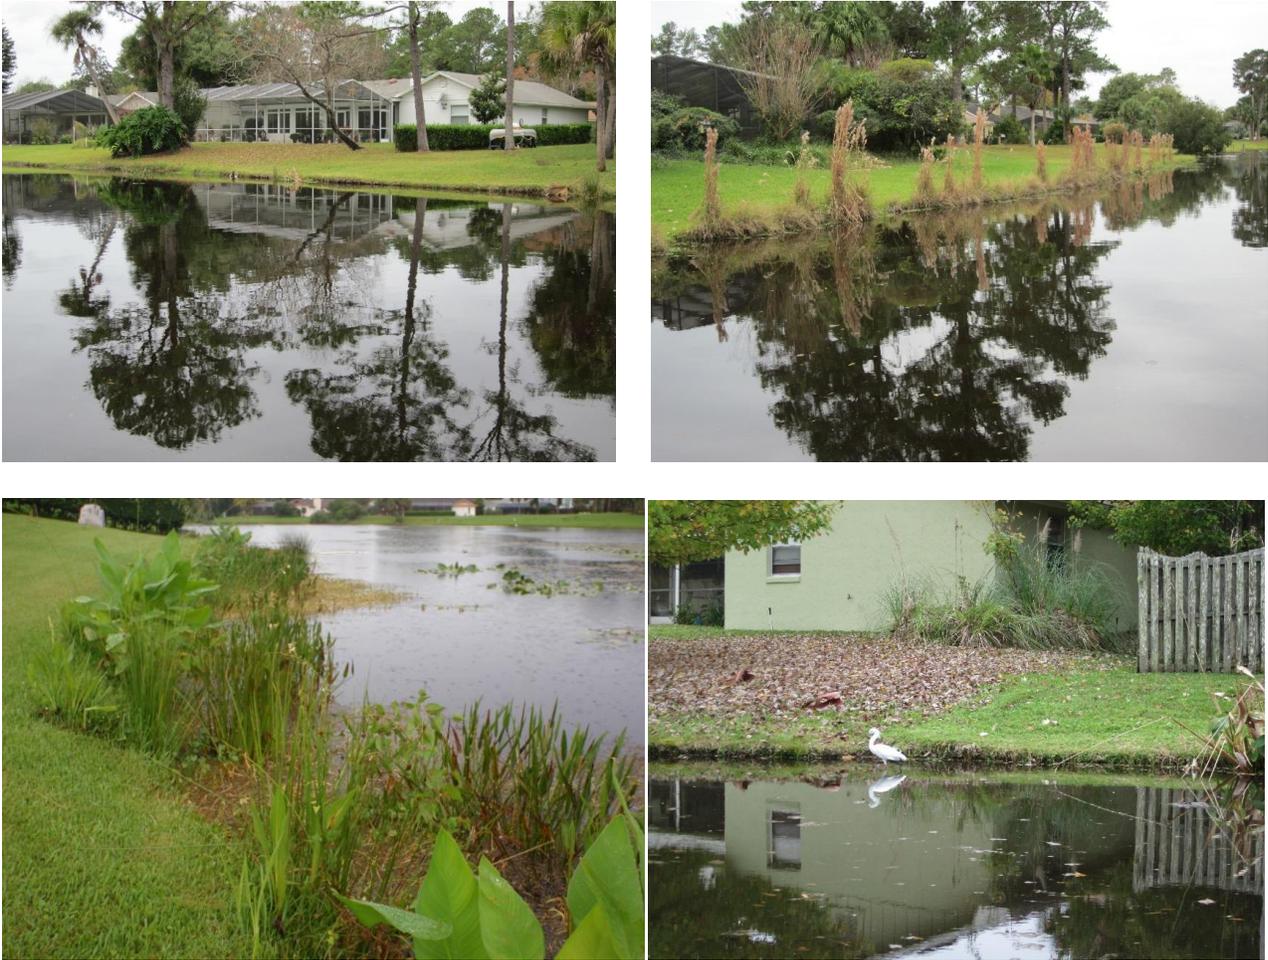
Figure 6-5. Examples of Shoreline Areas in the Lower Lobe of Sweetwater Cove.

Shoreline areas surrounding the lower lobe contain a wide variety of both species and density of aquatic vegetation which range from natural vegetated shorelines, to planted shorelines, to bare shorelines. Some of the shoreline residents have planted native plant species along their shoreline, while others maintain a cleared shoreline where virtually all aquatic vegetation has been removed from shoreline areas adjacent to their properties. Many areas exist where the rear lawn extends to the water's edge with no emergent shoreline vegetation at all. Photographs of current shoreline vegetation in the lower lobe are given on Figure 6-5.

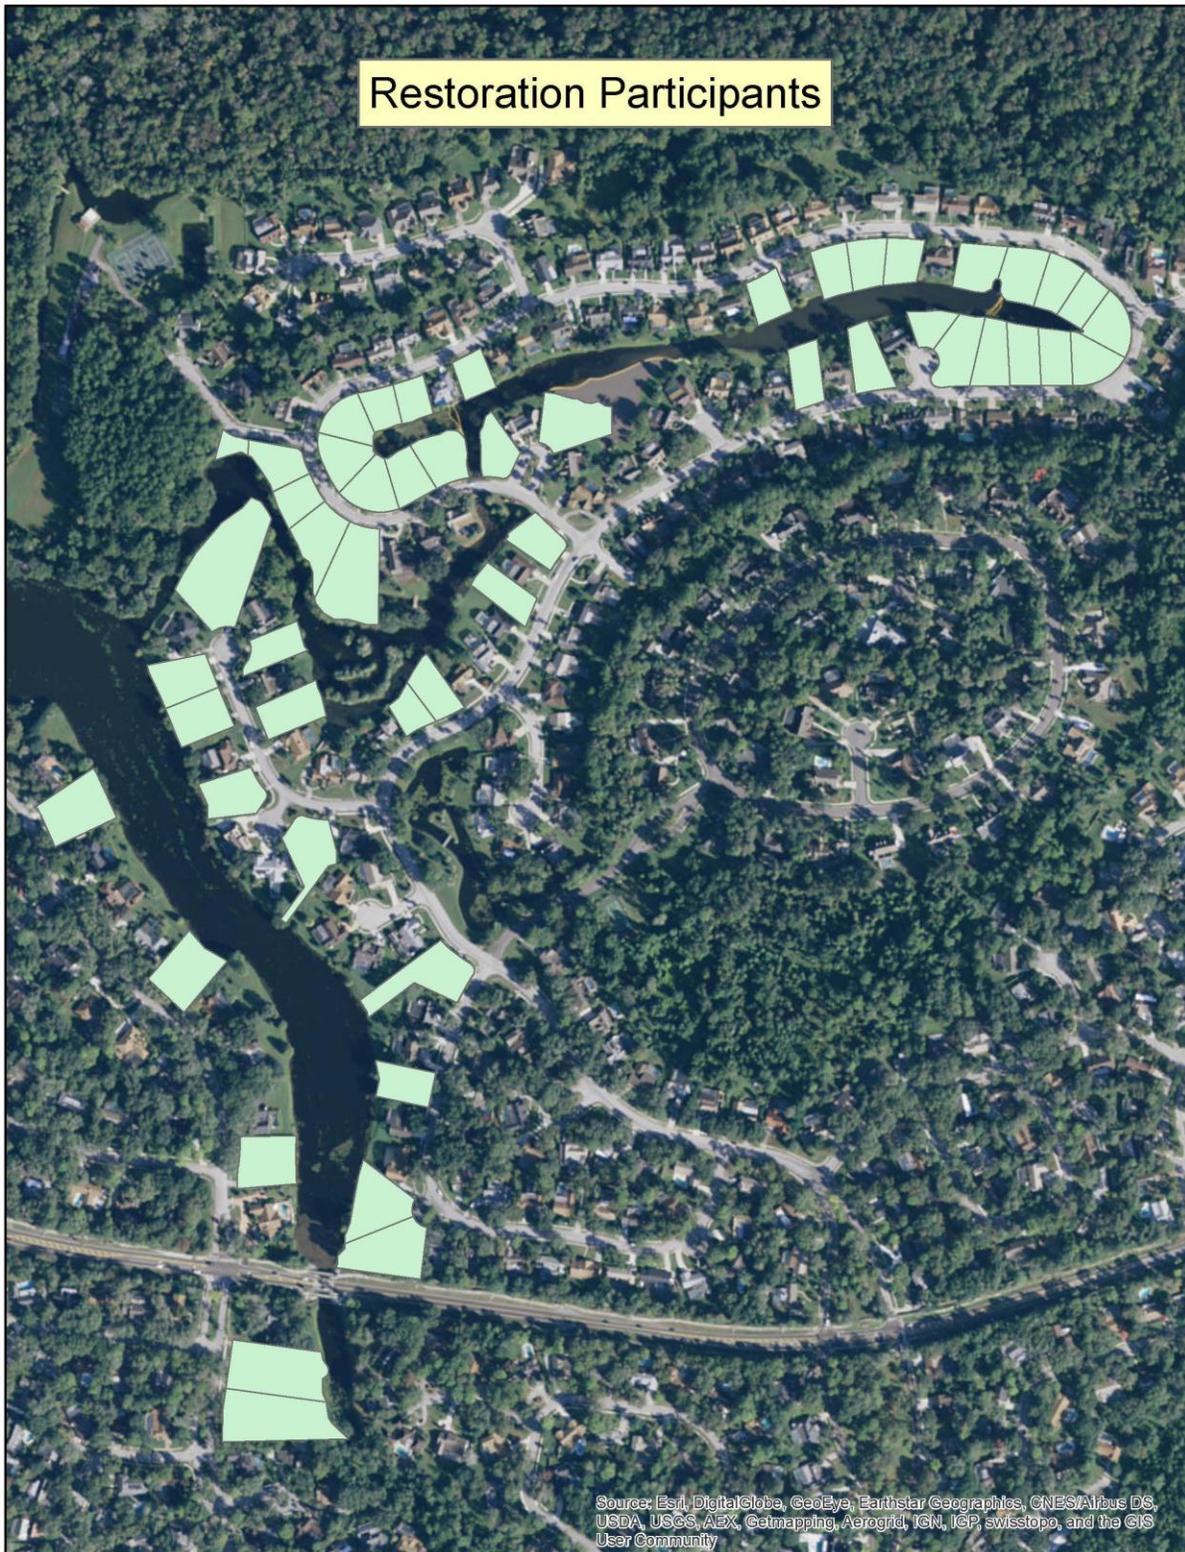
Figure 6-6. Parcels Participating in the Shoreline Restoration Projects.

An overview of parcels participating in the shoreline restoration projects is given on Figure 6-6. At this time, more than half of the current parcels located on the lower lobe have participated in the shoreline revegetation project. Similar shoreline restoration events have been conducted for the upper and middle lobes of Sweetwater Cove Lake.
